Sprague Creek Fen, Wetland Complex Restoration

Compensatory Mitigation Strategy for the Roseau Lake Restoration Project

Roseau River Watershed District

MNDNR Roseau River Wildlife Management Area Office

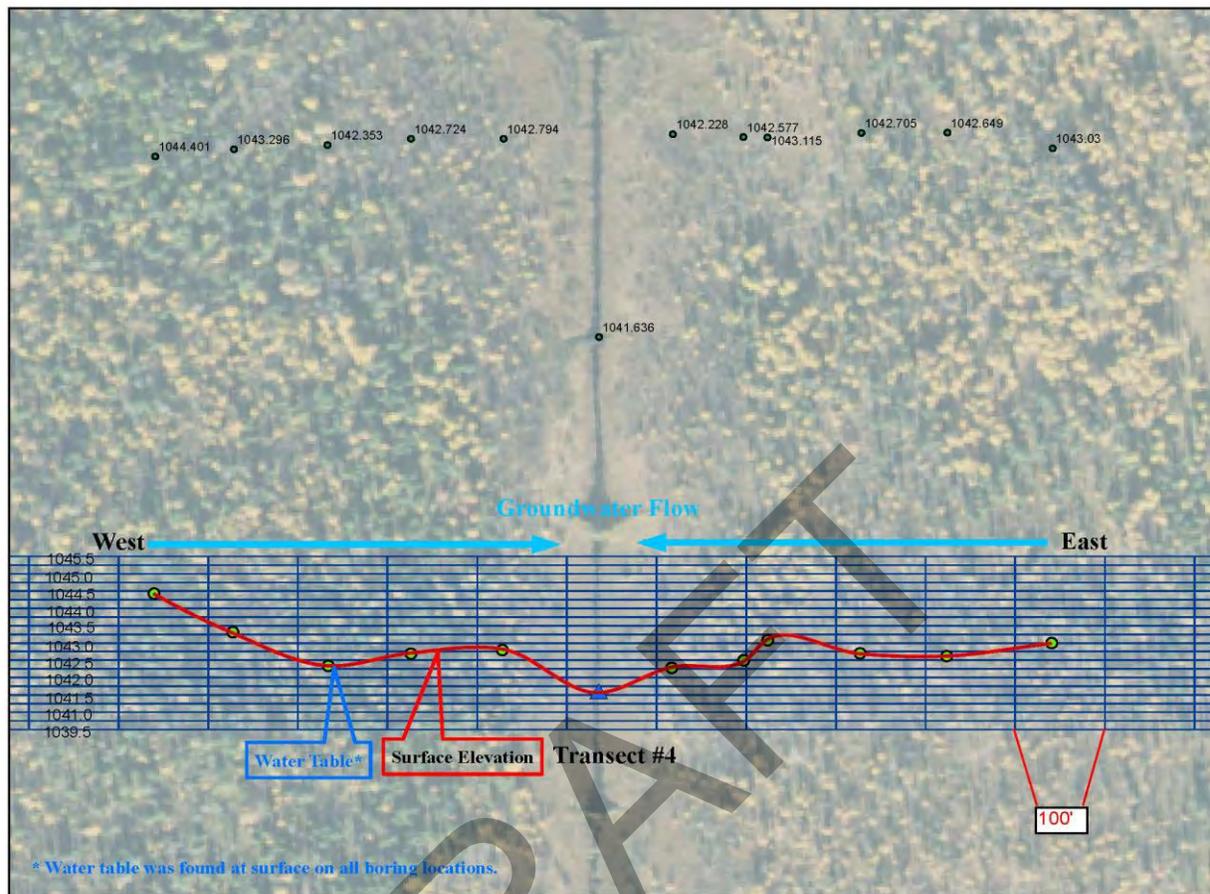
(Graphic #1) Transect #4 Cross Section, Lateral 5B Jurisdictional Ditch 61

Based upon elevation data collected in the field and cross sections derived from LiDAR data, there is substantial subsidence in ground elevation along the ditch corridor. This is likely a result of periodic, partial, or complete drying of the upper peat layers causing decomposition and/or flushing of organic material downstream. As a product of this decomposition process, the land on both sides of the ditch slopes gradually toward the channel. This potentially exacerbates dewatering impact on the landscape as surface water drainage increases over time.

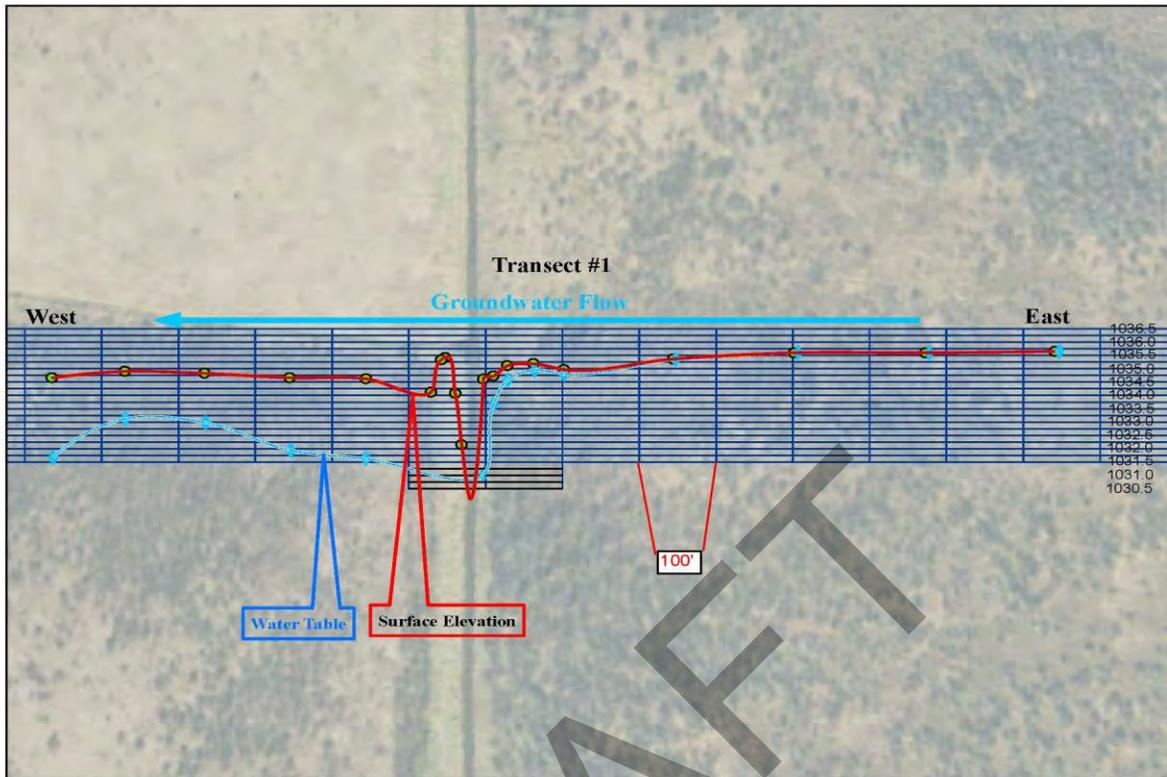
(Graphic #2) Transect #1 Cross Section, Lateral 6, Jurisdictional Ditch 61

Data collected during the 2017 field season identified hydrologic and vegetative impacts as a result of the ditch and spoil road. Impacts to the east of the ditch are typical of wetlands degraded by lateral effect. Vegetation condition, based on wC, is lower close to the ditch and improves as the transects extended further from the ditch. Wetlands east of Lateral 6 also exhibit a decrease in the water table the closer to the ditch. West of the ditch and road, there was a measurable impact on the water table and the wC scores of the plant communities. The lower wC scores and decrease in groundwater elevation is likely due to groundwater being intercepted by the ditch while the road composed of compacted peat, acts as a aquatard further compounding the loss of hydrology west of the road. There is an observable rise in groundwater levels as the transects extended further westward, likely due to groundwater pressure pushing upwards as it moves beyond the ditch and roadway.

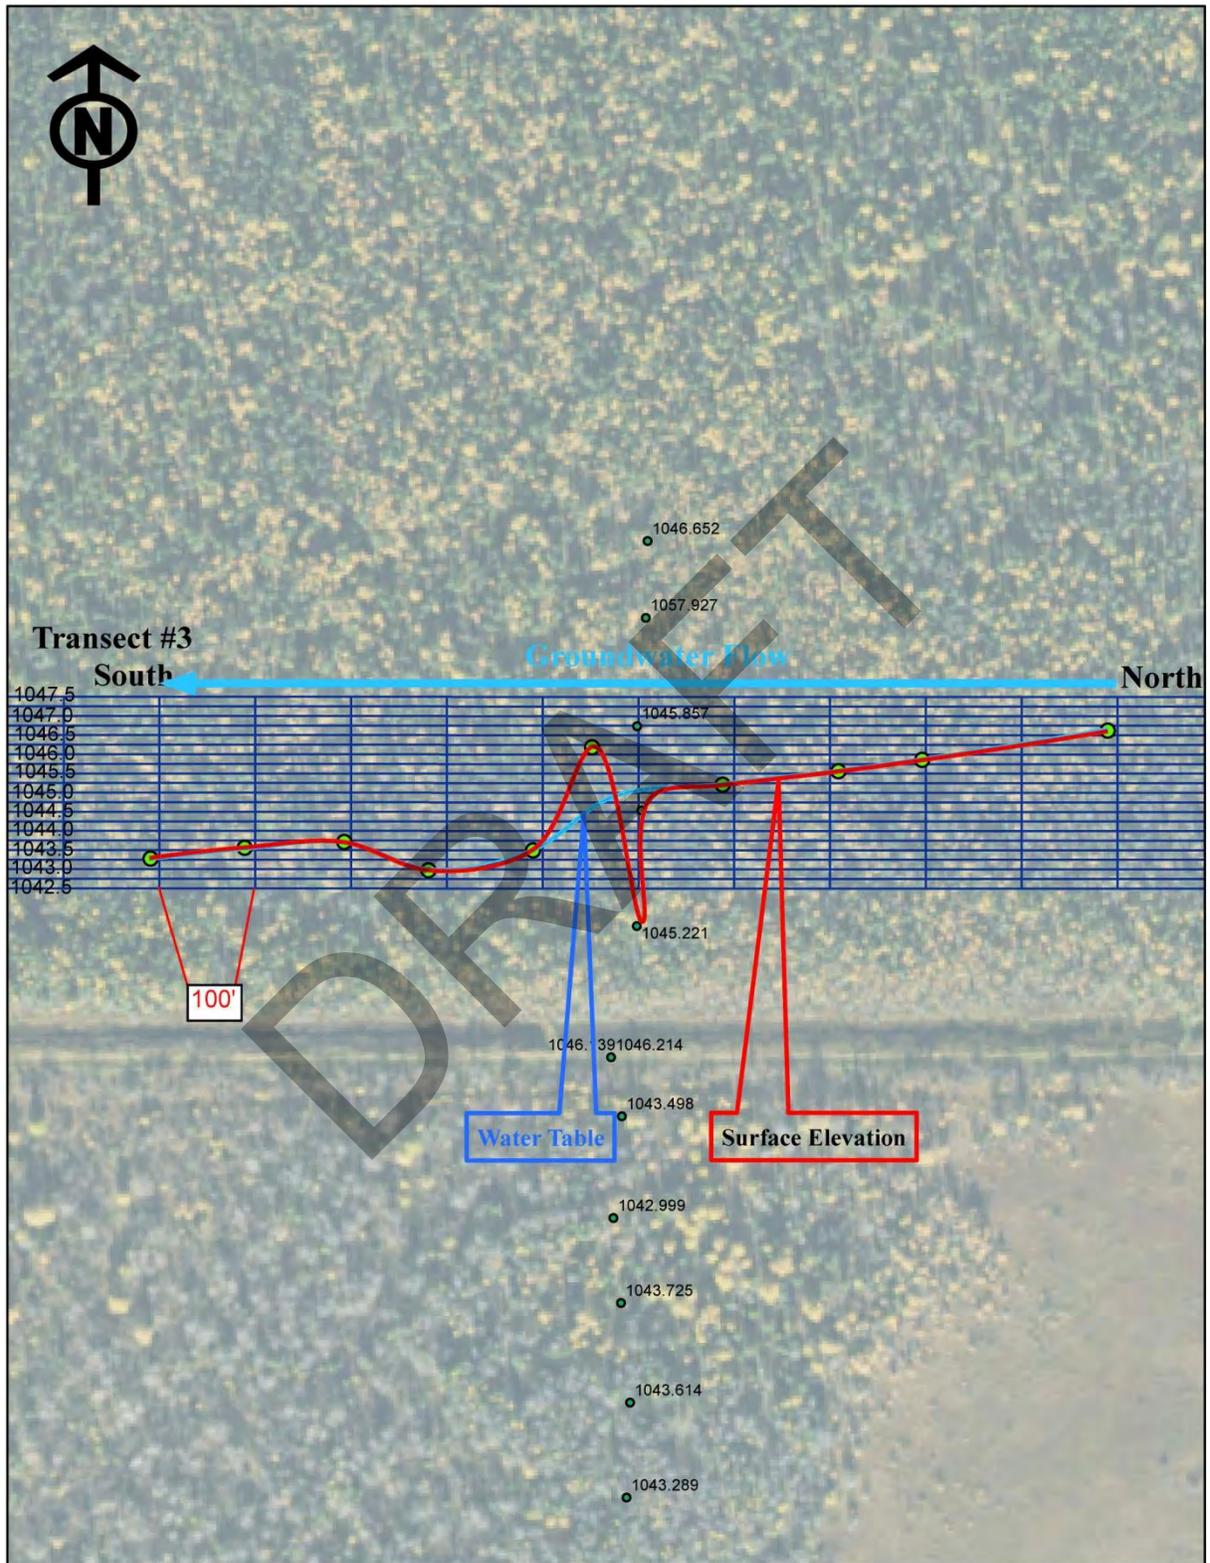
(Graphic #4) Transect #3 Cross Section, Lateral 7 Branch 1, Jurisdictional Ditch 61

Data collected from transects #3 and #5 provided information upgradient and downgradient of the lateral to determine if there is any impact on vegetation due to altered hydrology. Transect #3 is located to the east of the SNA and reflects similar plant communities that characterize the Sprague Creek SNA. On the north side of the ditch, the plant communities are dominated by high-quality native vegetation with no occurrences of invasive species. South of the ditch, the wetlands have more generalized species and invasives; high-quality vegetation was still present but at lower densities. Transect #5 is located west of the SNA and exhibits similar characteristics to Transect #3. A more complete analysis can be found in the FQA exhibit.

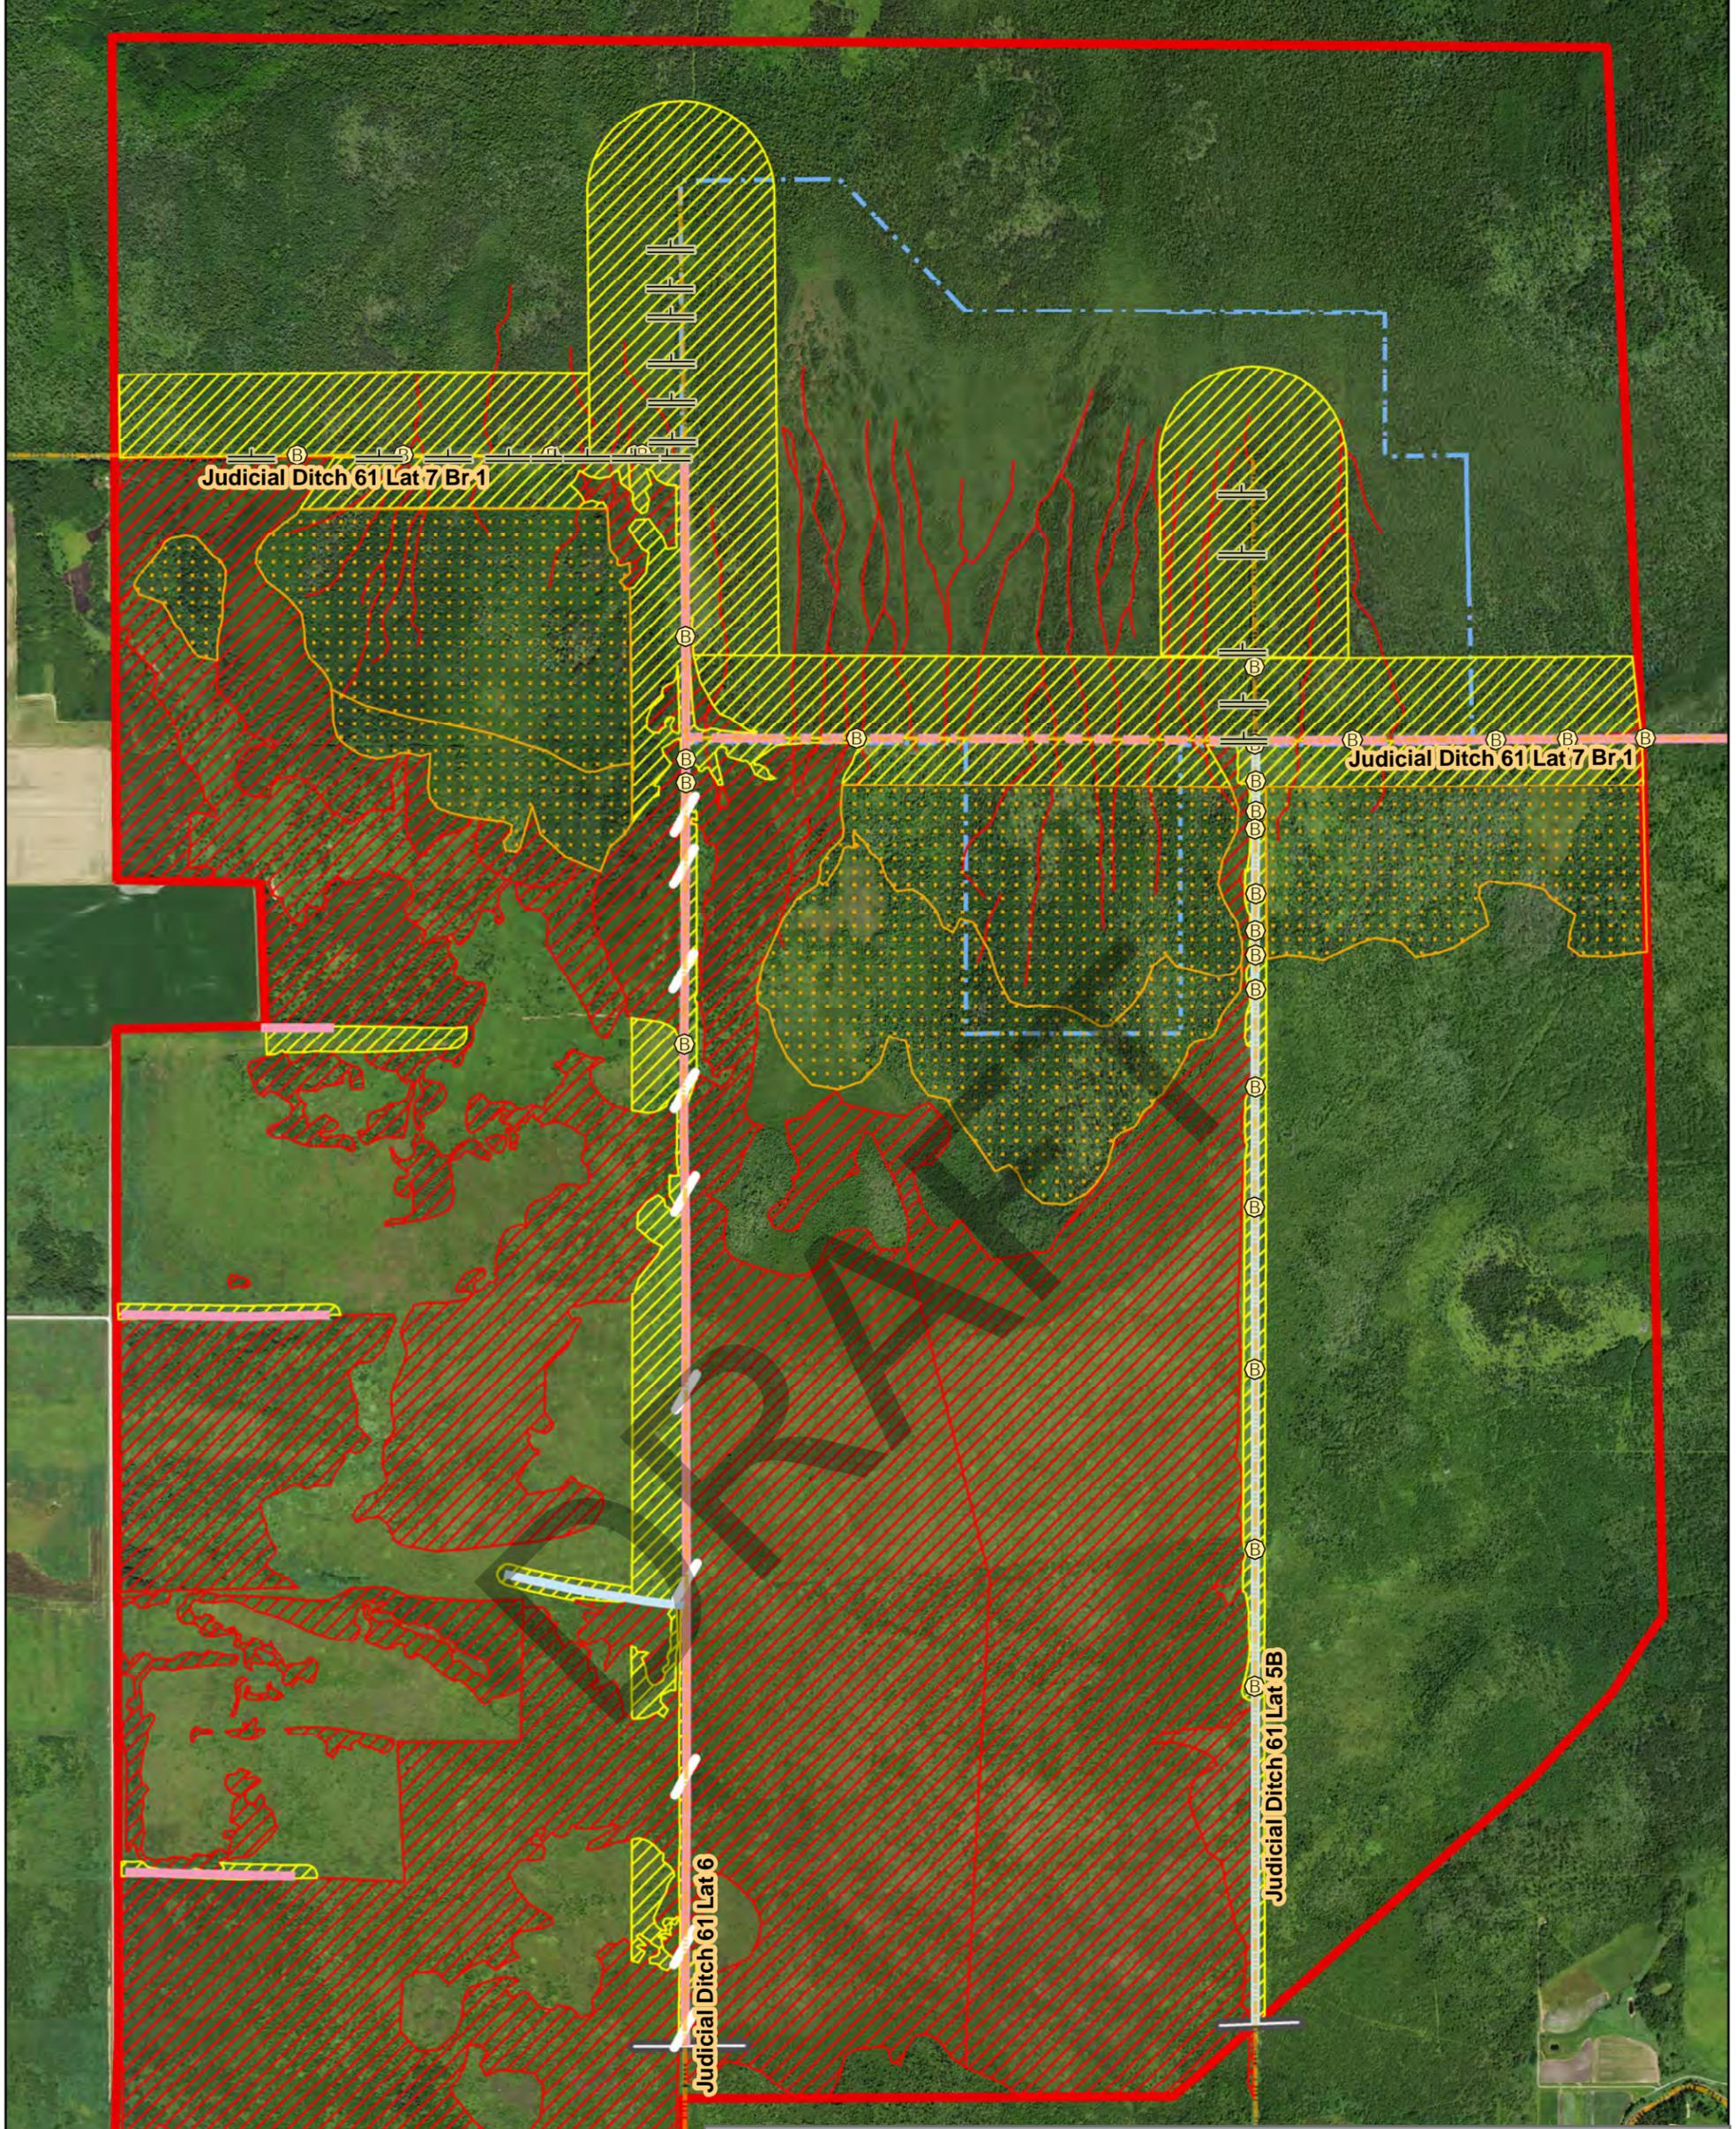
Figure #1
Site Map

Site Map
All Restorative Practices

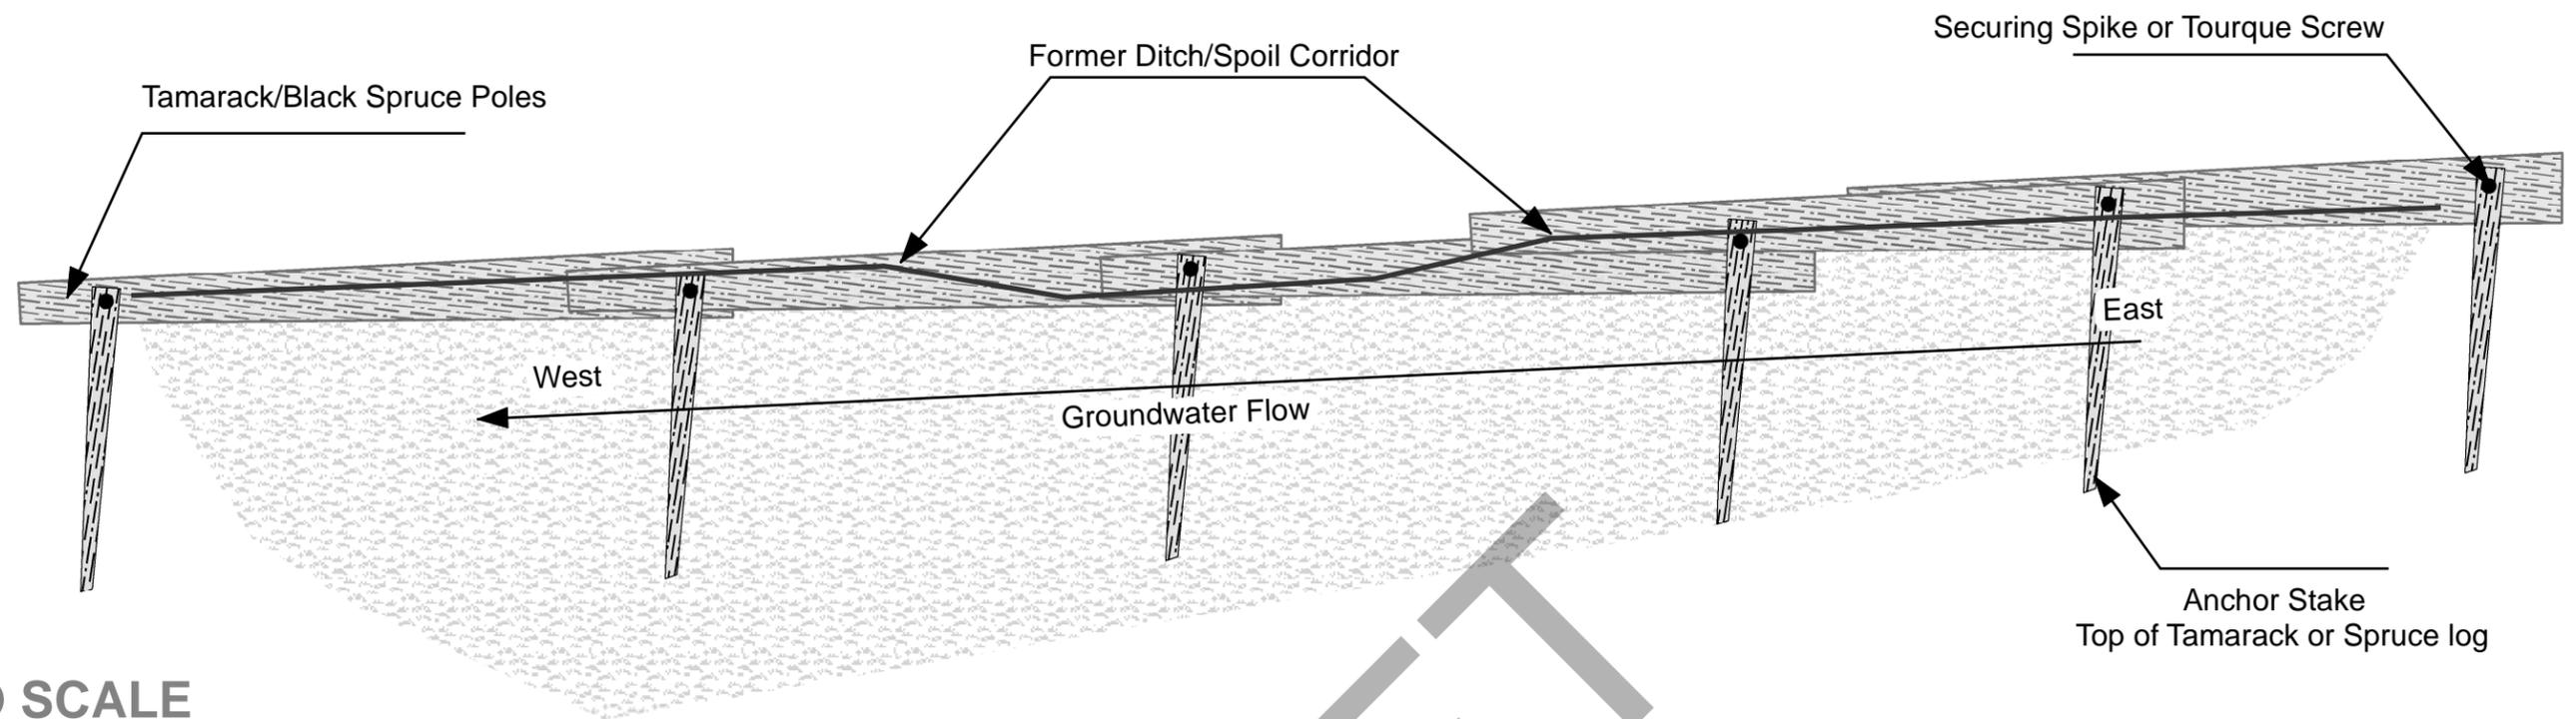
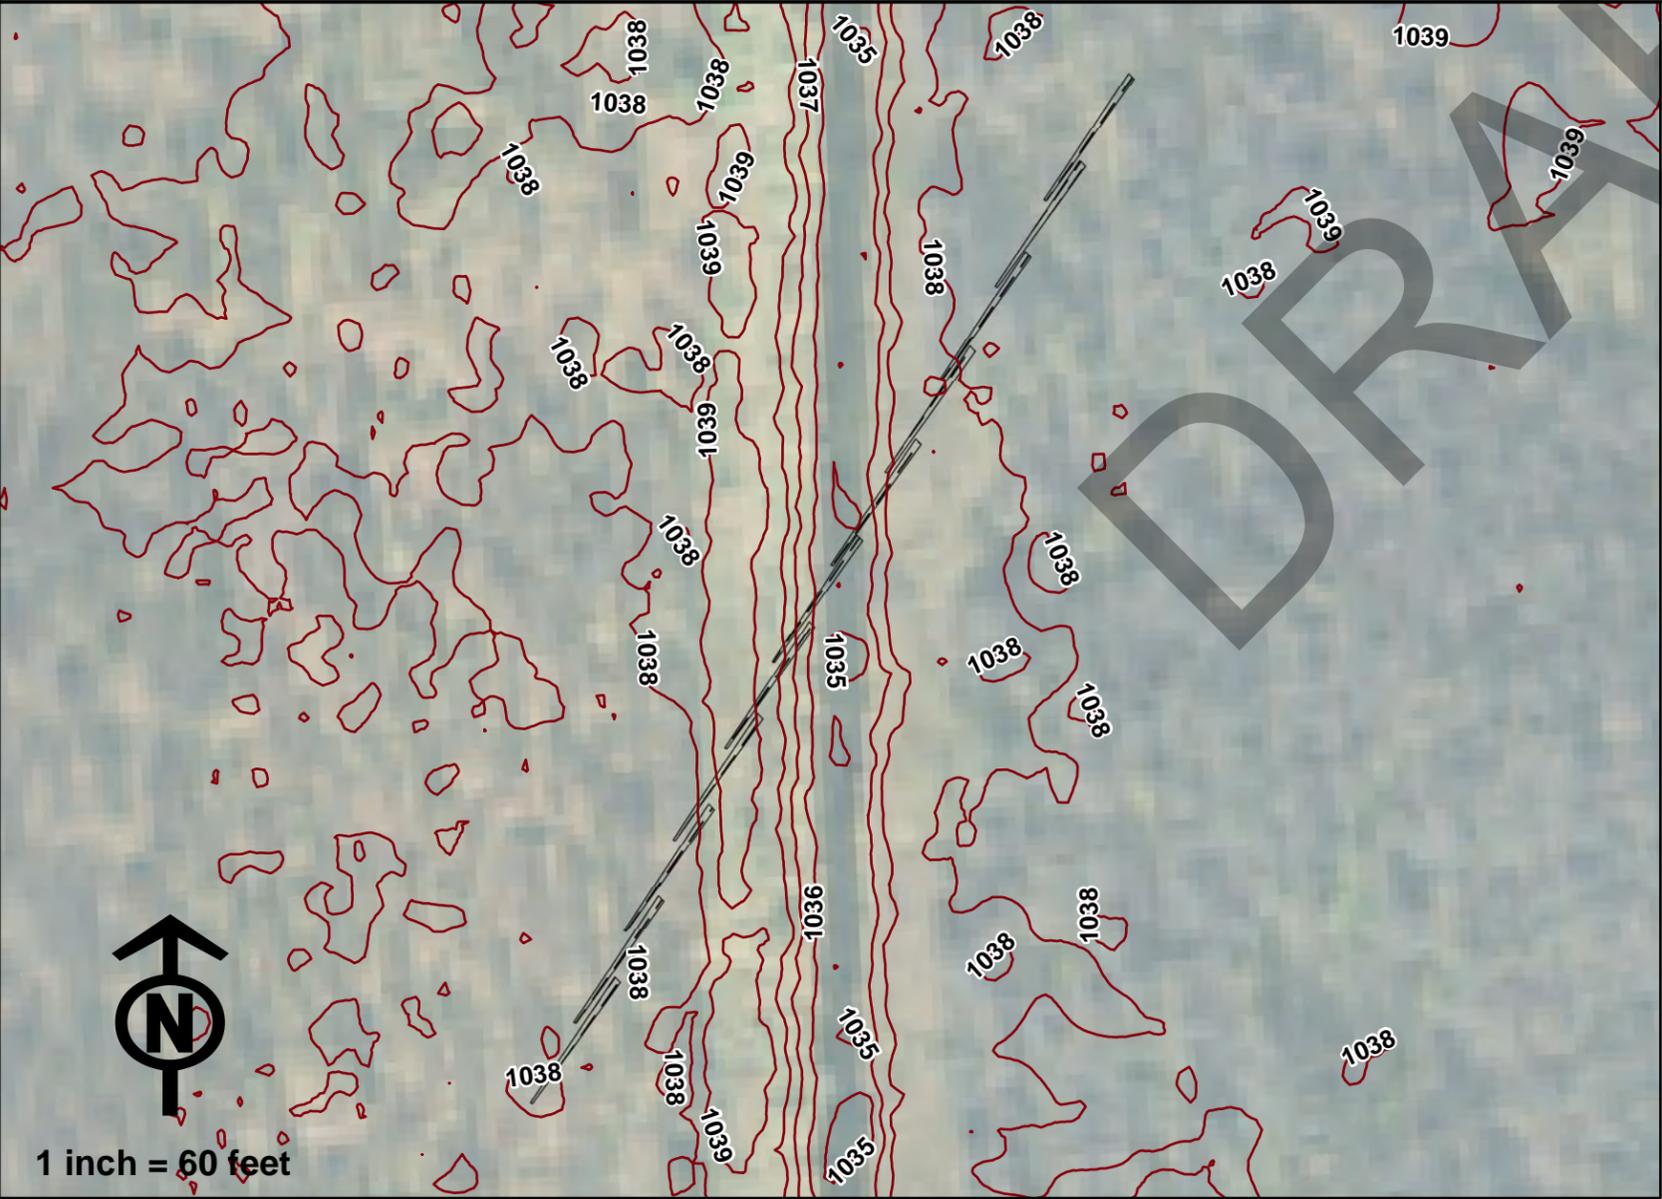
Log Diversion Structure Design

1. Logs harvested will consist of de-limbed Tamarack or Black Spruce
2. Minimum thickness of logs shall be no less than 12" top diameter
3. Logs shall be placed with the base oriented to the east, with the top angled at 215° from true north. Logs will be lapped with first log installed at the east station, each subsequent log will be placed south of the log before it.
4. Stakes comprised of the upper 4' of Tamarack or Spruce will be driven 3.5' into the peat, pole shed spikes or long torque screws will be driven through the stakes and into the logs to anchor the structure in place
4. Stakes will be installed 1' from the base of the log, for each individual log. An additional stake will be installed on the top of the westernmost log, this will prevent potential rotation and/or damage.

There will certainly be areas where insufficient spoil is available or the degree of subsidence makes transitioning hydrology from east to west across the corridor of disturbance difficult. To address this, log diverters will be installed in the former corridor of disturbance to aid reestablishment of flow direction (Figure 8, Log Diverter Exhibit). Logs will be sourced from within the property, likely with the aid of DNR Forestry to identify suitable stands. Tamarack or Black Spruce are the preferred species due to their slow rate of decay and abundance. Onsite conifer logs are preferable to fill in order to prevent introduction of invasive vegetation and promote a suitable medium for remnant invasive stock to re-colonize the site.

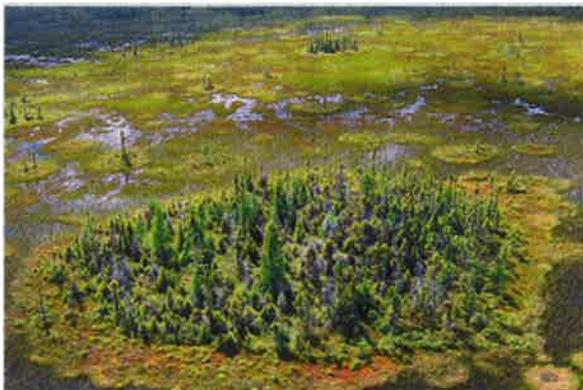
Raised bogs are one of Minnesota's most prominent peat landforms. These forested areas are domed in cross section, isolating the bog surface from mineral-rich runoff draining from adjacent uplands. When a bog has developed sufficiently in elevation, it forms a **crest** of black spruce that radiates out from the center, when viewed from aerial photos. Trees gradually become more stunted downslope from the crest as the peat becomes more saturated. At the lower margins, spruce trees give way to non-forested sphagnum lawns (muskeg). Raised bogs can also occur as **circular or, egg-shaped ovoid islands** that lack crests of black spruce. Circular or ovoid islands

generally form when adjacent to water tracks (see below).

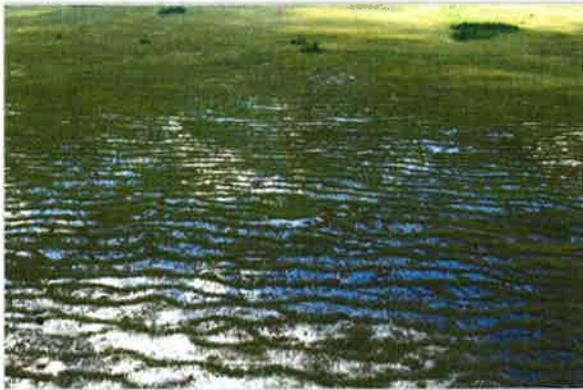
Water tracks are fen areas in peatlands that look like river channels on aerial photos. They are concave in cross section and oriented downslope in the direction of water flow. Water flow is imperceptible on the ground because of the very subtle change in topography (1 foot in elevation for every 1,000 to 2,000 feet of distance). Water tracks are often bordered by swamp forests or raised bogs. A water track may be patterned or featureless:

Patterned water tracks or fens contain networks of peat ridges (known as ribs or strings) and pools (known as flarks) that form perpendicularly to the slope and flow of water. These patterns resemble

ripples when viewed from aerial photos. These water tracks may also contain **teardrop-shaped tree islands**, that are oriented parallel to the prevailing slope and flow of water.

- **Featureless water tracks** lack the ripple patterns of patterned water tracks, although they may have linear bands of tree islands parallel to the flow of water.

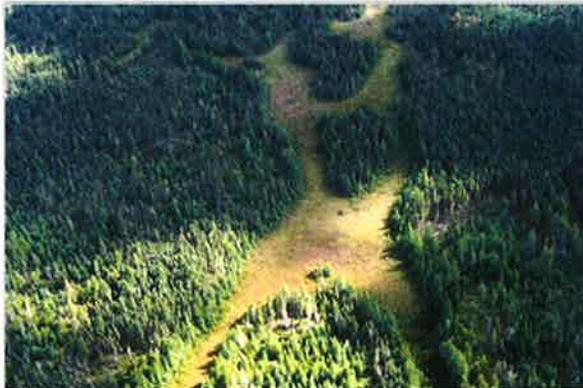
Spring fens develop where groundwater wells up strongly, through the peat layer. The flow of discharging groundwater forms a network of narrow channels that flow through and dissect black spruce and tamarack swamp forest. The channels often rejoin as they flow, creating small linear-shaped swamp forest islands. The water in spring fens is cold, oxygen poor, and highly calcareous (alkaline), reflecting the ground water source.

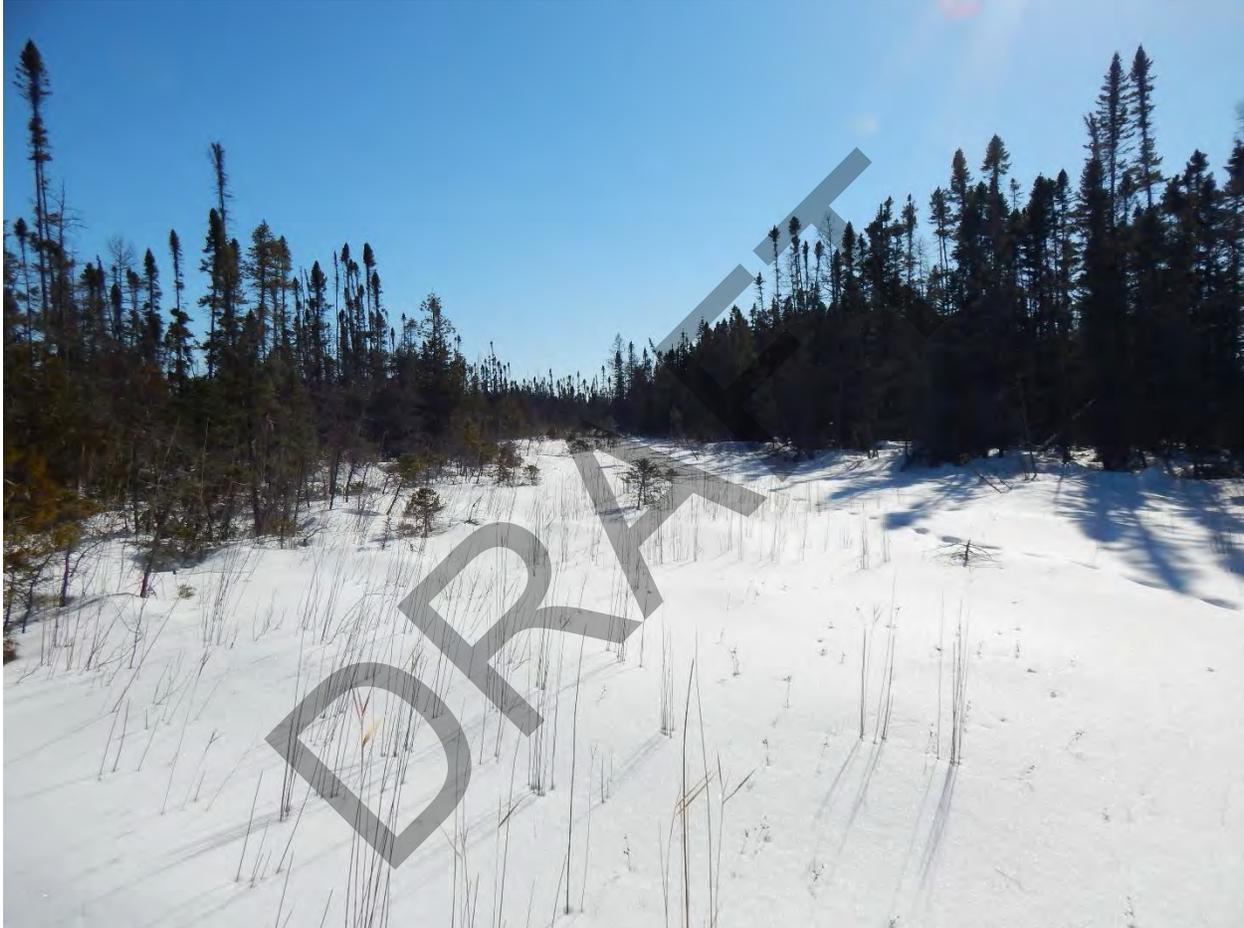
Spring Channel (#16) South Aspect, Sprague Creek SNA February 2018

Photo located approximately 2,000ft north of JD61 Lat7 BR1

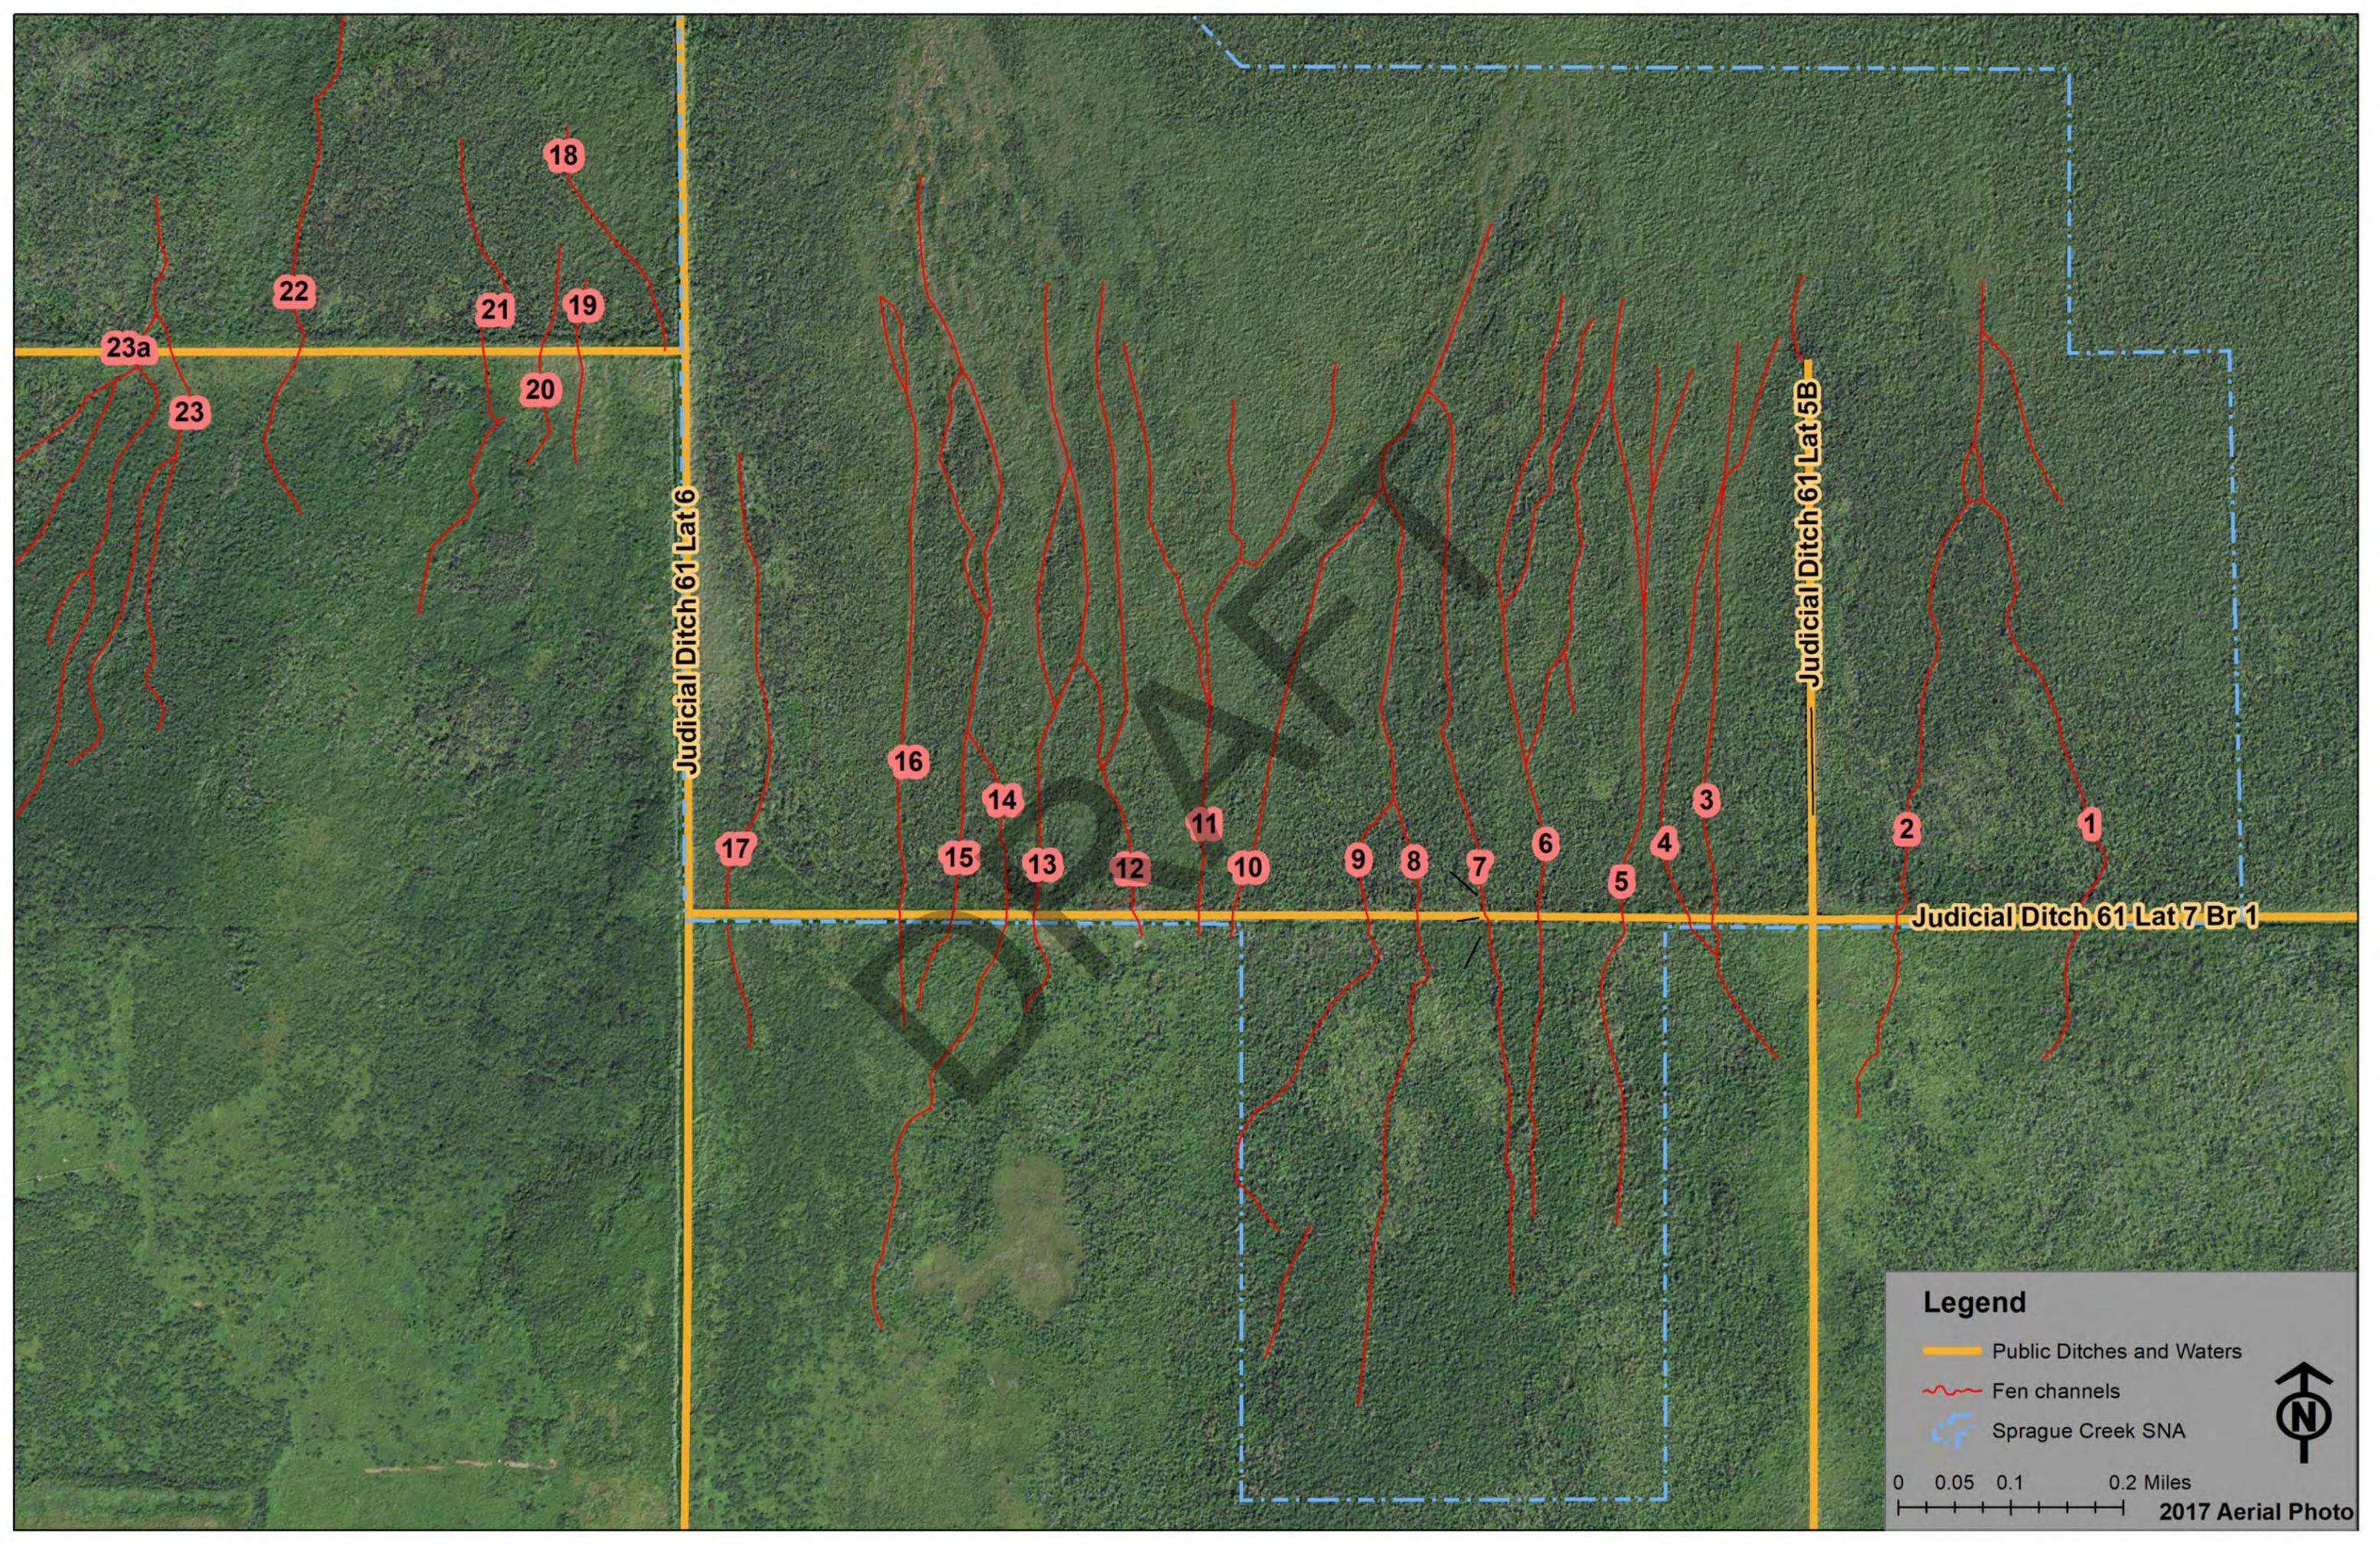
Profiles were generated for 23 spring channels (1-17,19-23a) beginning 30-60 meters north of the ditch and extending 30-40 meters south of the spoil. Profile alignments were delineated from historical aerial photography and LiDAR interpolation. Ten of the profiles included an addition profile (Noted in chart as *LiDAR adjustment*) to provide terrain derived alignments addressing potential downstream discrepancies in elevation. The graphs for each spring channel illustrate elevation over distance, with the x-axis illustrating station numbers in meters and the y-axis depicting elevation above mean sea level.

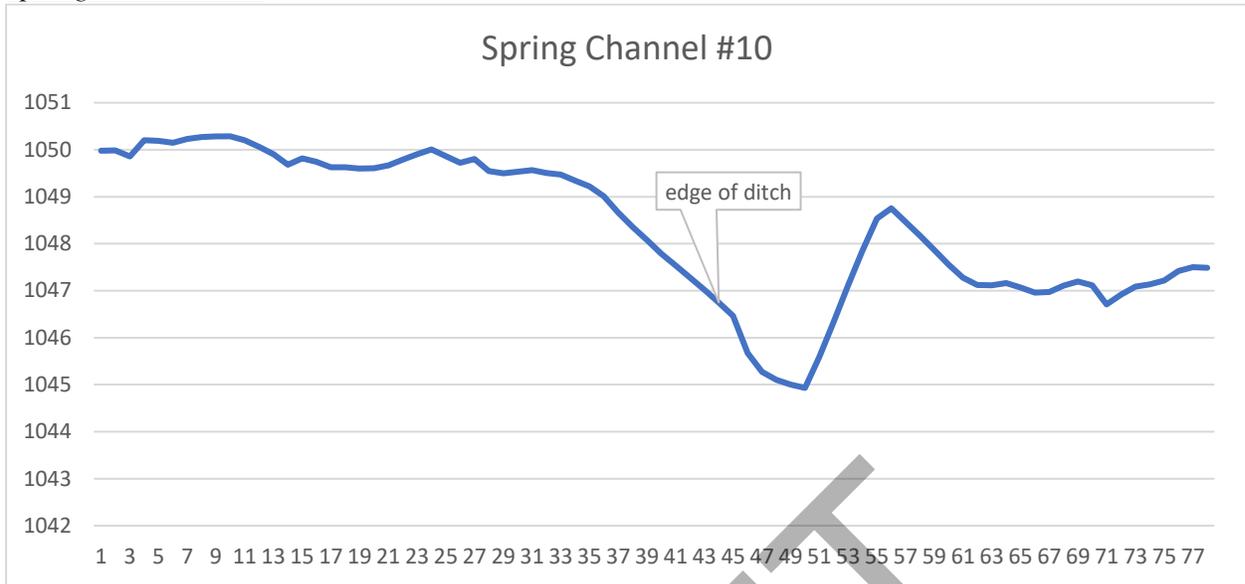
Spring Channel #10

The profile depicts elevation from north to south (left to right). Based on the elevation of the north ditch edge and the ground south of the spoil, plugging the ditch adjacent to the channel may impound 0.2-0.7” of surface water along 2 meters of fringe.

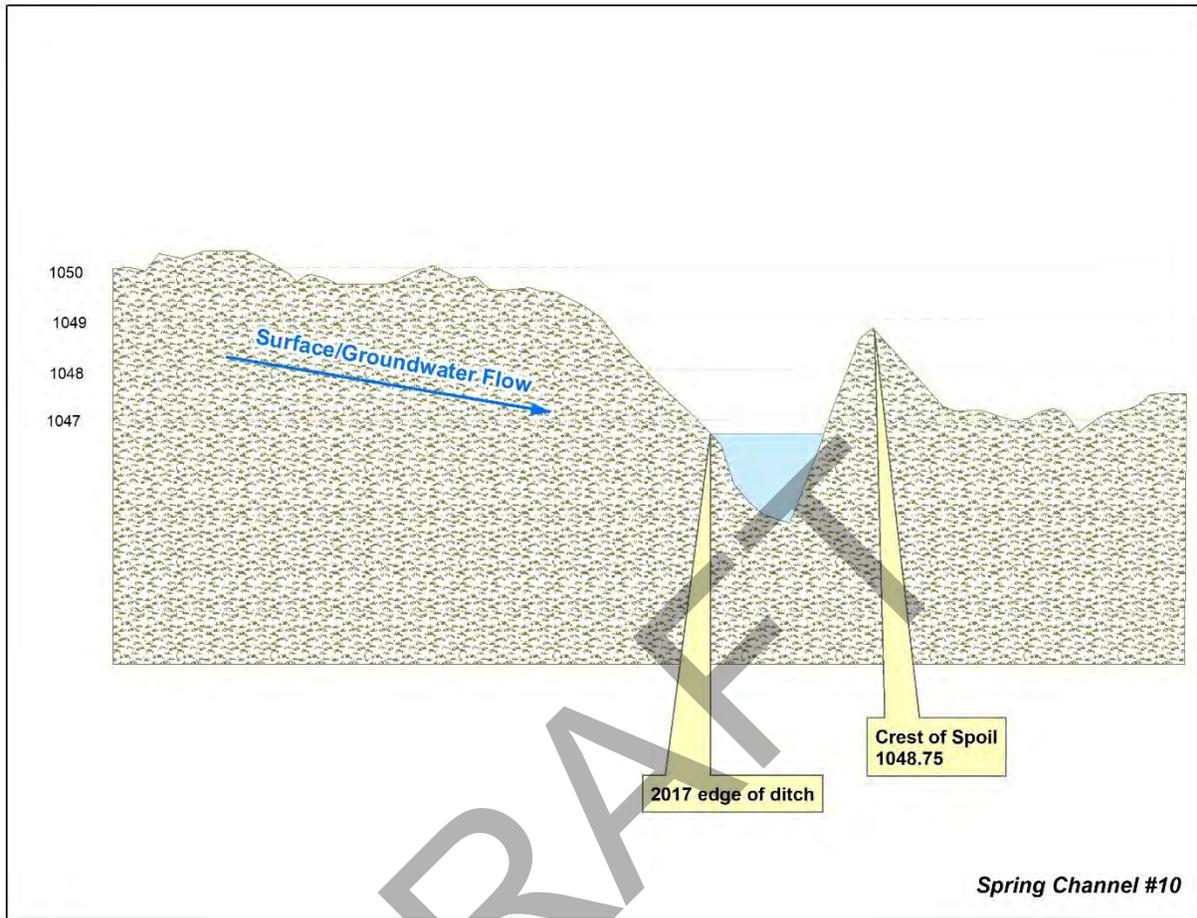
Graphic #1 illustrates a typical cross section of a Spring Channel within the Sprague Creek SNA. Terrain within the SNA slopes from north to south (left to right) with ditch spoil buttressing the south side of the ditch. Water levels within the ditch can fluctuate 2-3ft depending on discharge into the ditch and condition of beaver dams within the channel.

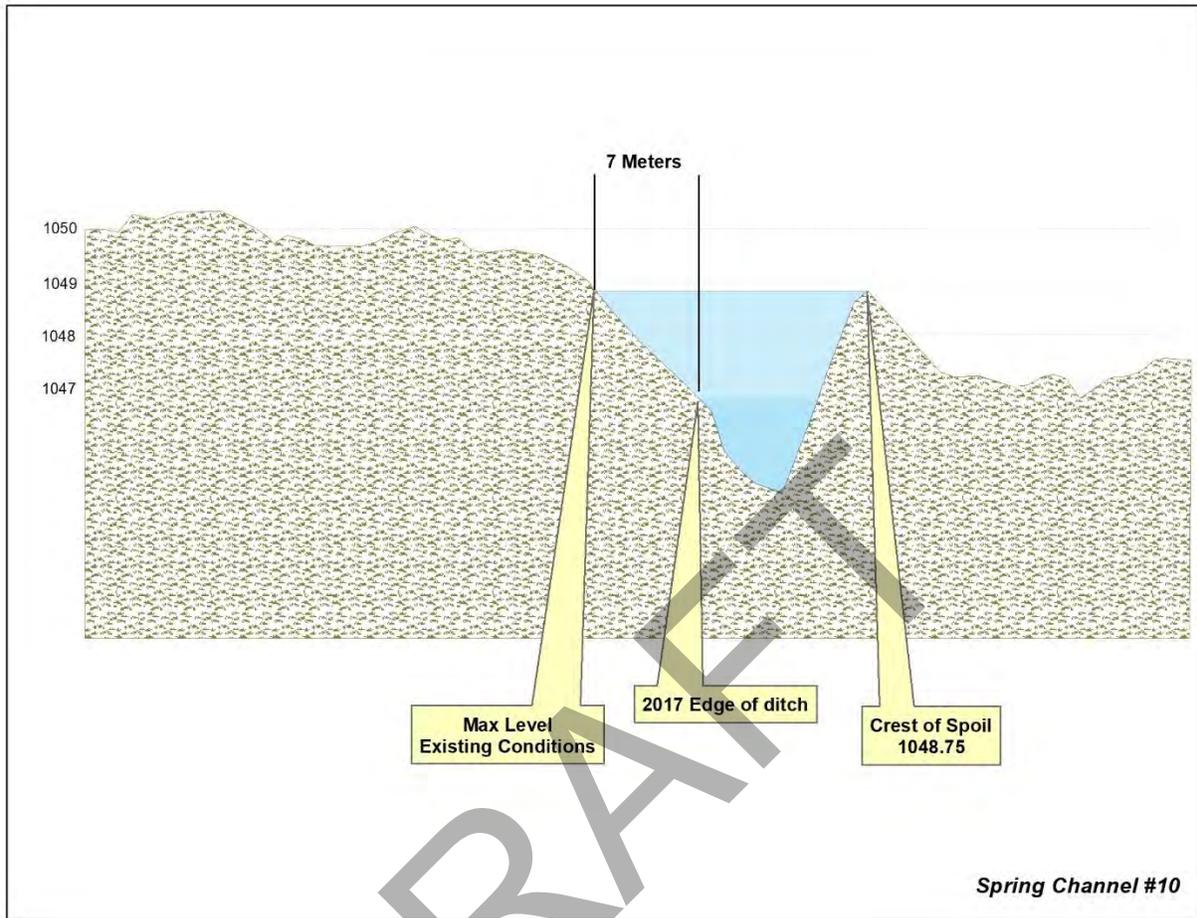
Graphic #2 illustrates maximum potential impact to the fen, north of the ditch. During a large discharge event, or if a beaver dam were constructed to the crest of the spoil, a 7 meter wide band of the fen would be inundated. Conversely, if the ditch were to be cleaned or the beaver dams removed from the system entirely the northern edge of the ditch could experience further desiccation.
