Sprague Creek Fen, Wetland Complex Restoration

Compensatory Mitigation Strategy for the Roseau Lake Restoration Project

Roseau River Watershed District

MNDNR Roseau River Wildlife Management Area Office

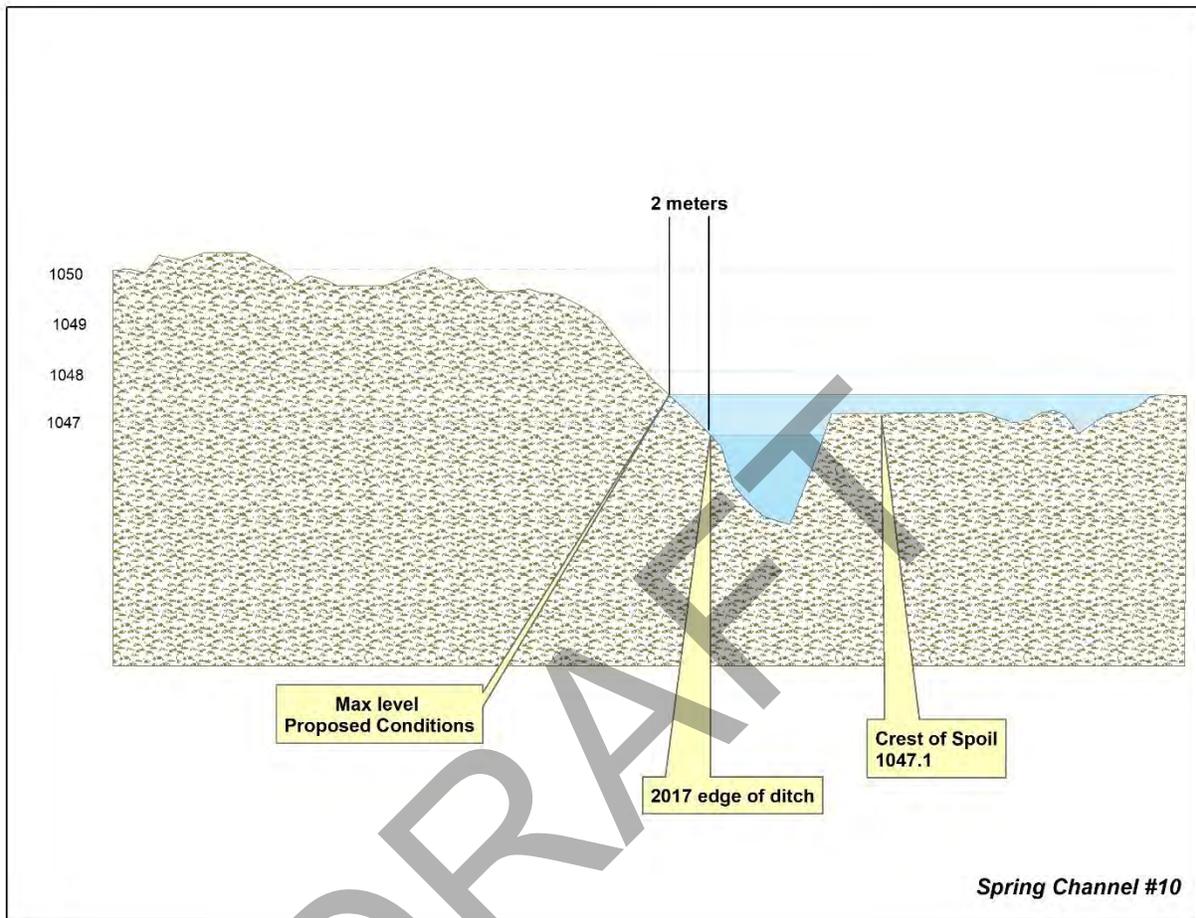
Graphic #3 is the maximum potential impact to the spring channel, post restoration. Note that the band of inundation has been reduced from 7 meters to 2 meters. The hydraulic gradient through the cross section would be coaxed southward by installation of plugs east and west of the channel, the former spoil location would have the upper layers agitated to mimic pre-impact conditions. The combination of ditch plugs and agitating the compacted peat in the former spoil alignment will promote a more stable hydrograph and re-establish hydrologic connectivity to wetlands south of the ditch.

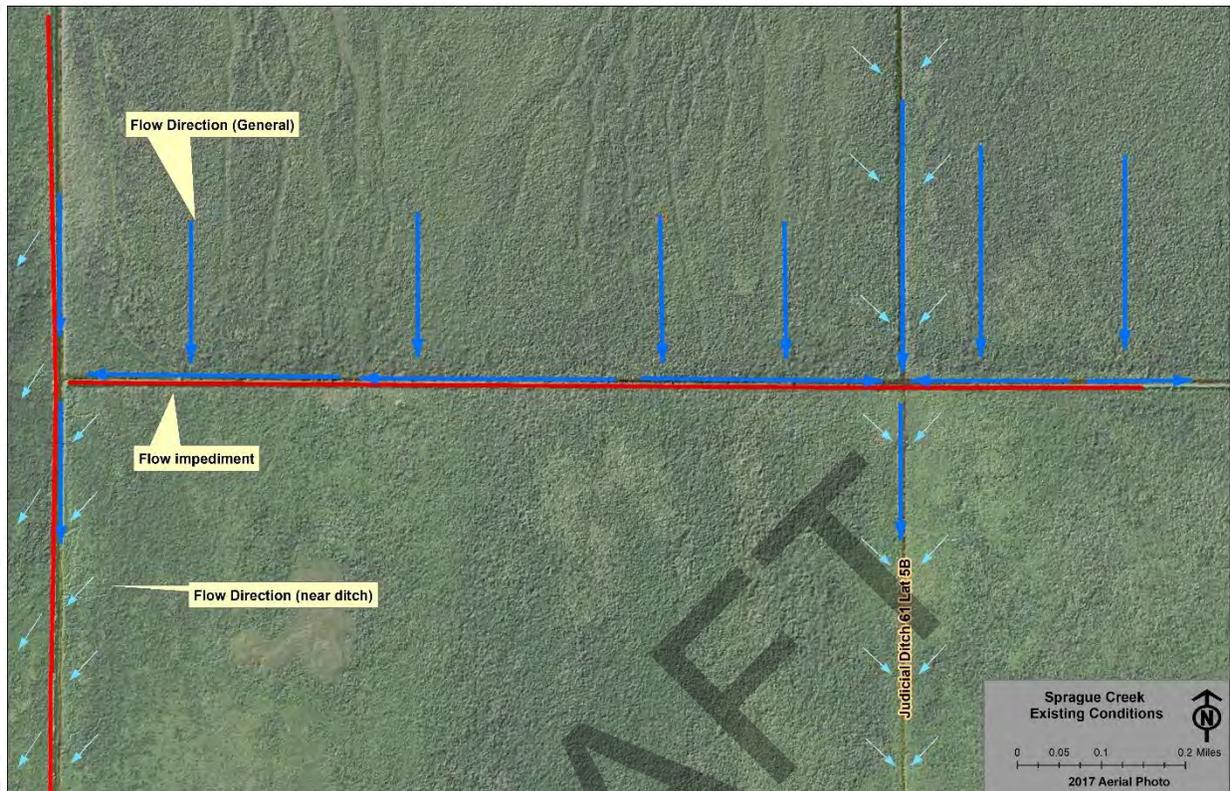
Graphic #4

The above graphic depicts simplified surface hydrology, with the primary flow direction in dark blue, flow obstructions (spoil) in red, and secondary flow near the ditch illustrated in light blue. Interception and redirection of hydrology is evident along Lateral 7 Branch 1 of JD 61. Remnant northeast to southwest gradient is still somewhat intact along the Lateral 6 corridor, while the terrain along Lateral 5B has subsided, subsidence has resulted in focal flow southward along the ditch corridor.

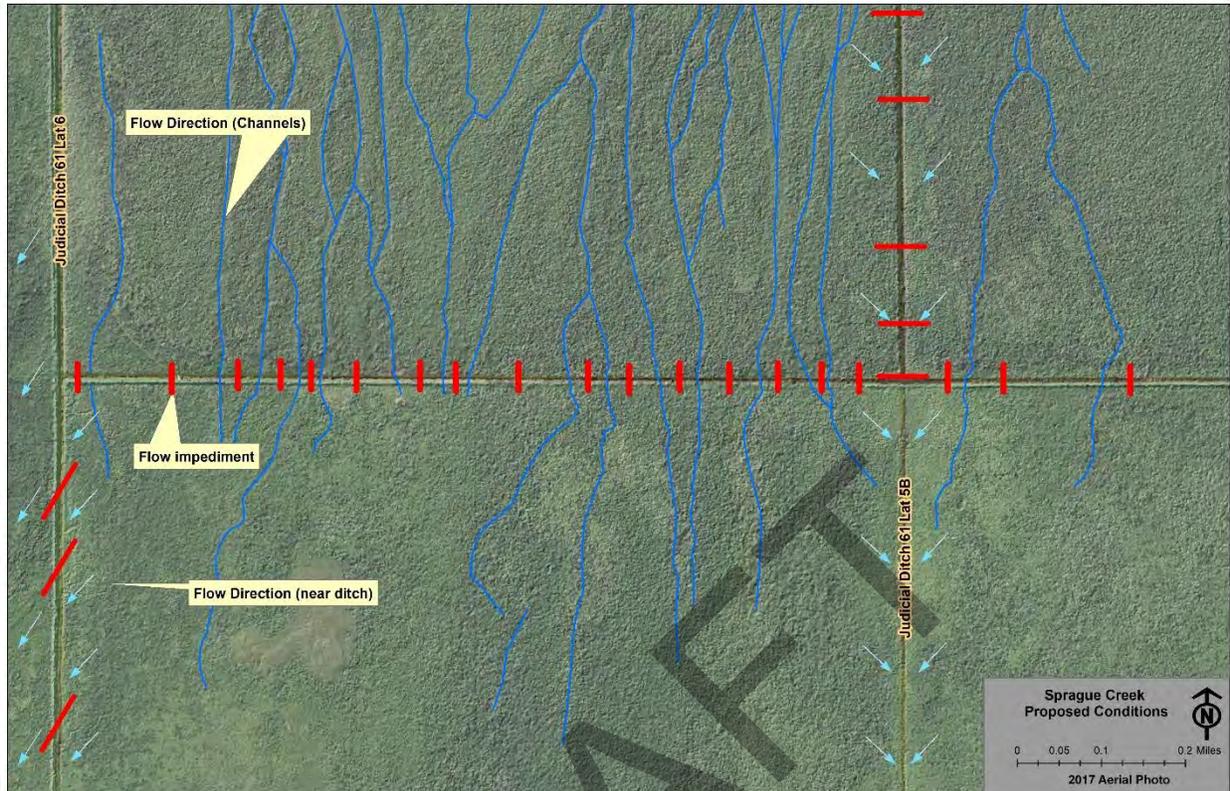
Graphic #5 depicts the alignment of proposed obstruction of existing drainage to mimic pre drained hydrology. Graphic #5 omits hydrologic modifications in Lateral 6 north of Lateral 7 Branch 1, and Lateral 5B south of Lateral 7 Branch 1, and Lateral 5B south of Lateral 7 Branch 1. Omitted modifiers consisted of replacing spoil in Lateral 6 to restore grade, and placement of brush and woody debris in Lateral 5B in lieu of spoil placement.

Spoil along the entirety of Lateral 7 Branch 1 would be removed from the south ditch bank. Spoil would be replaced in the open ditch system between the identified channels in areas identified as Spruce/Tamarack islands (see red vertical lines). The lines depicting the spoil locations do not represent extent of fill placement, simply the strategy of placement between channels.

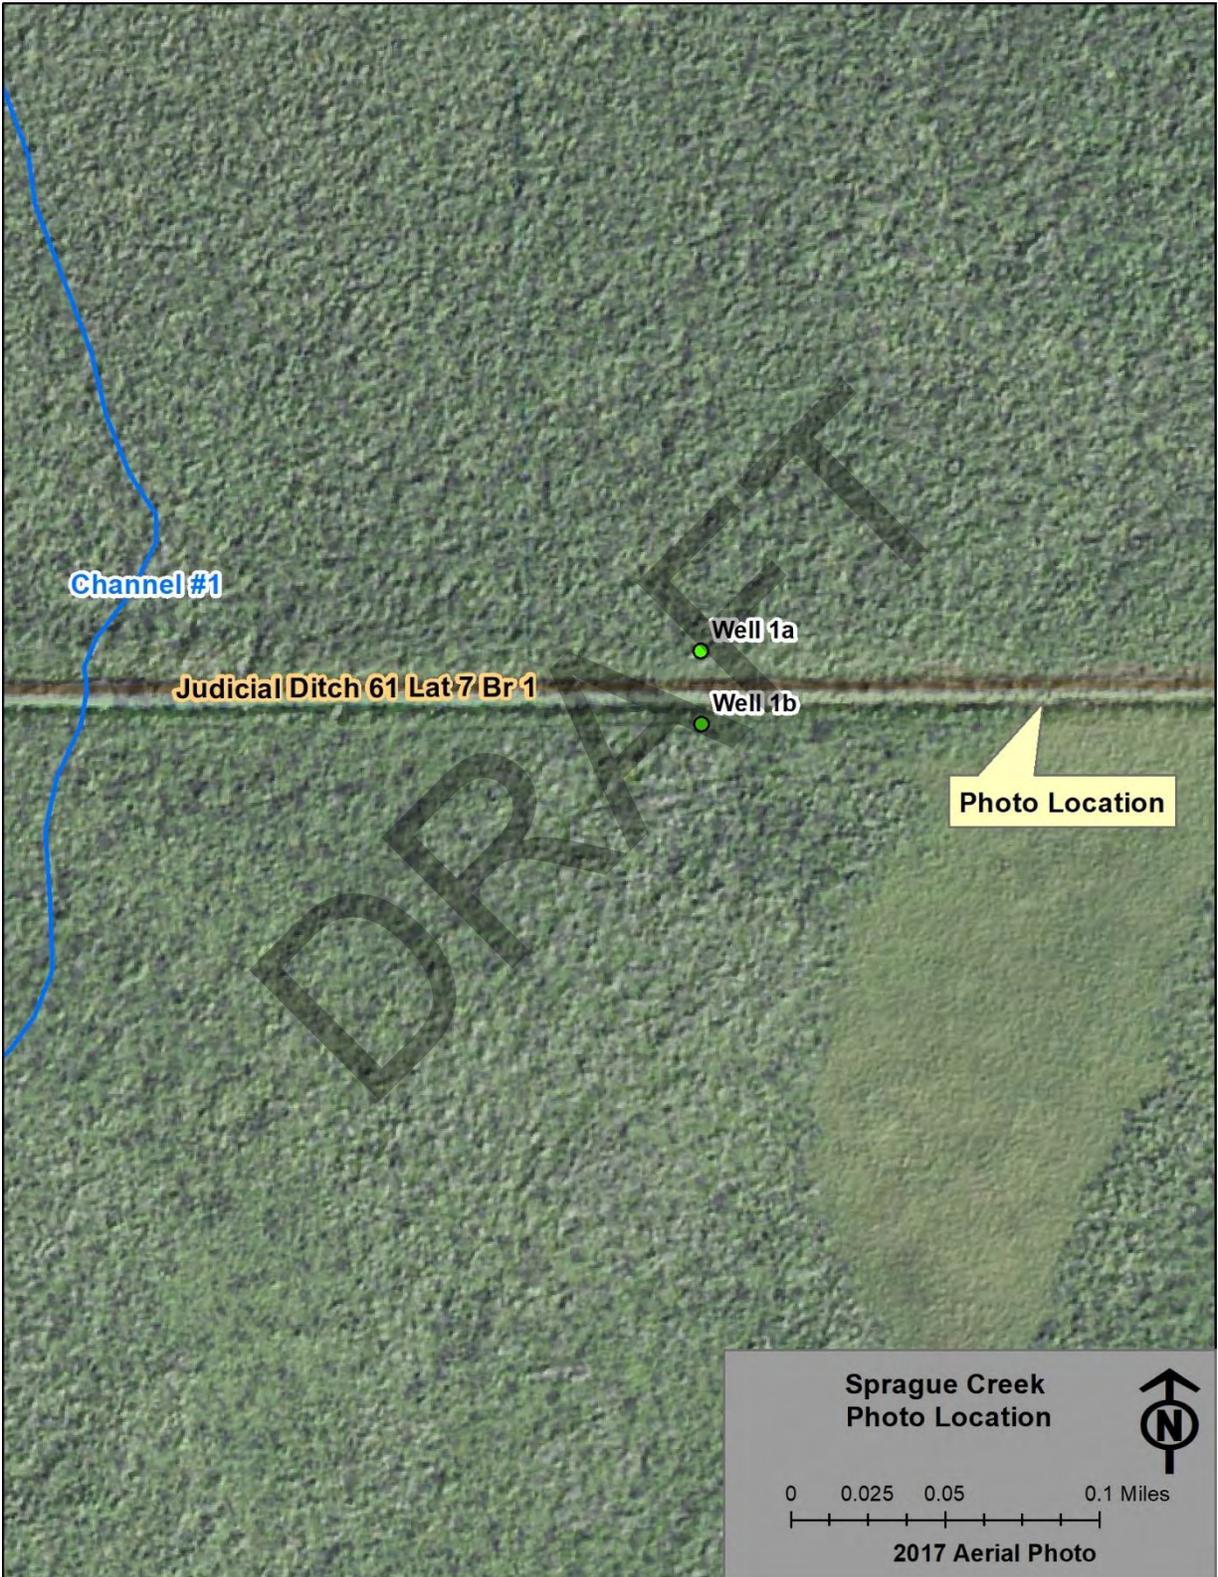
Graphic #6 is a photo location to provide context for the photos in Graphic #7 and #8. The Photo location is approximately 1,600 ft east of Spring Channel #1. Photos were taken atop the spoil bank, at the intersection of the spoil and a large beaver dam constructed prior to 2003.

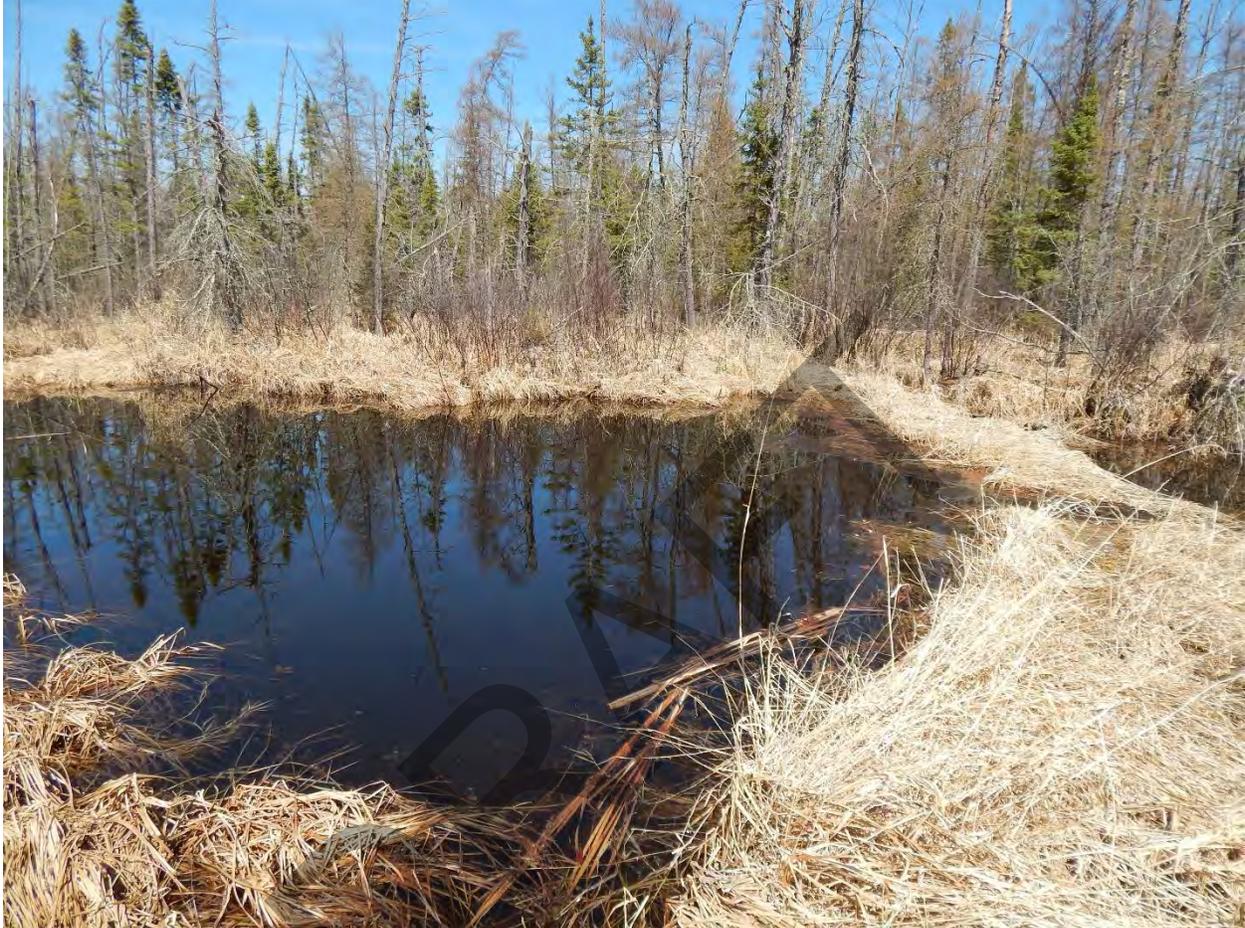
Graphic #7

Image taken from spoil bank facing north towards Spruce and Tamarack dominated wetland communities. Note, the change in surface water elevation from the left side of the beaver dam to the right side of the dam. This particular beaver dam has been in existence long enough for grass species to colonize the muck and debris.

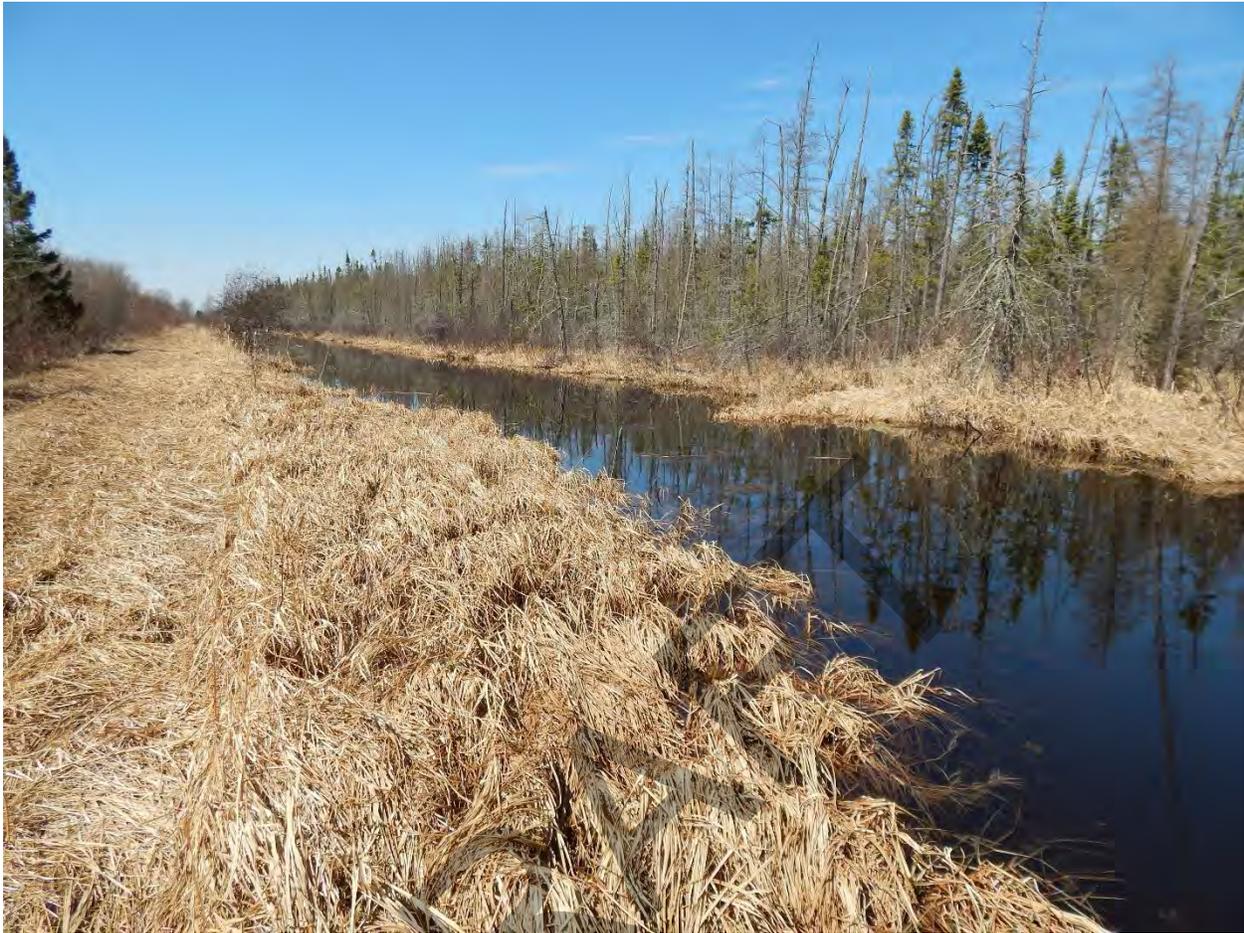
Graphic #8

Image from same location shown in Graphic #6 and #7 with a westward aspect along the Lateral 7 Branch 1 corridor. Surface water elevation at the photo location was within 6” of overtopping the spoil at the date of the image. Evidence of weeping were encountered on the south side of the spoil, likely due to inconsistencies or decomposition of peat within the spoil alignment.

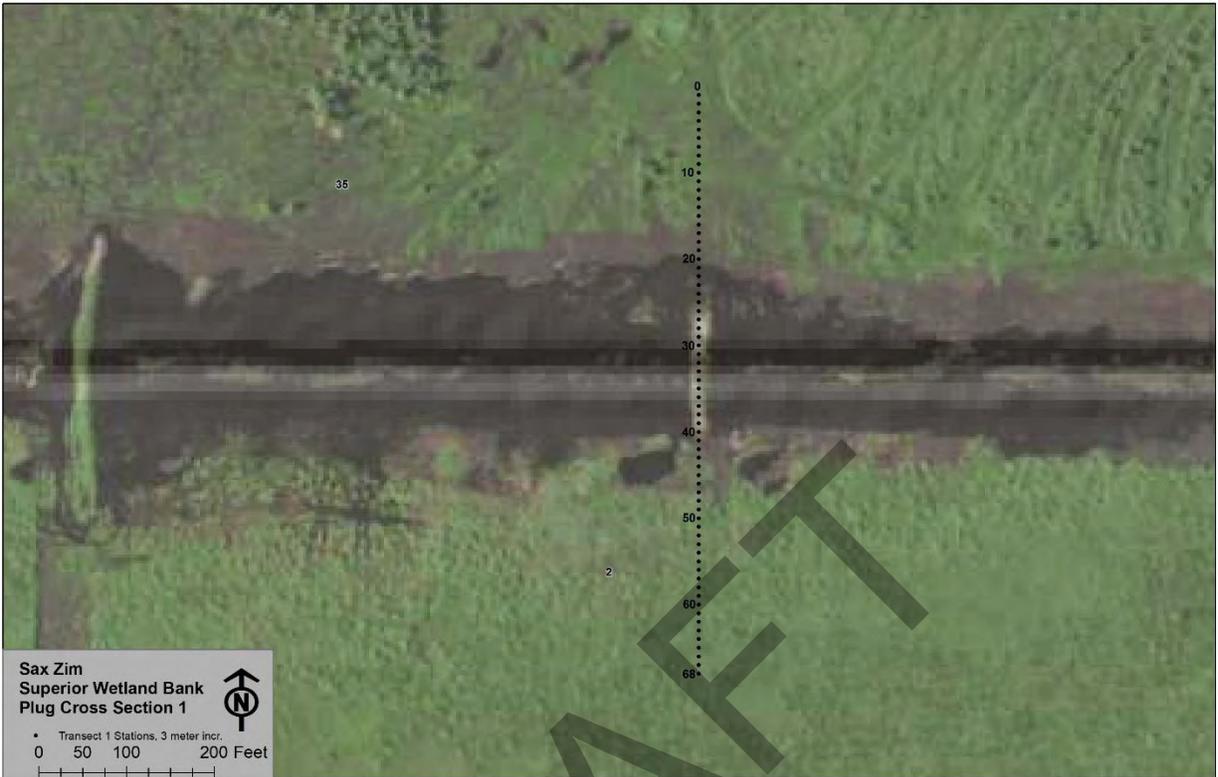
Graphic #10

Cross Section 1 depicts a ditch check located approximately $\frac{1}{4}$ east of CSAH 7 (See Graphic 9) which has encountered erosion due to surface water flows over or around the check dam. The imagery collected in 2017 shows evidence of inundation beyond the limits of the check dam which has prompted concerns of impact to peat communities along the ditch and the potential success of the restoration targets. A cross section was collected using LiDAR data, specifically 3meter digital elevation model (DEM), the DEM was converted to grid points in the same fashion as the profiles collected in the spring channels. Stations (3 meter spacing) are shown in the graphic.

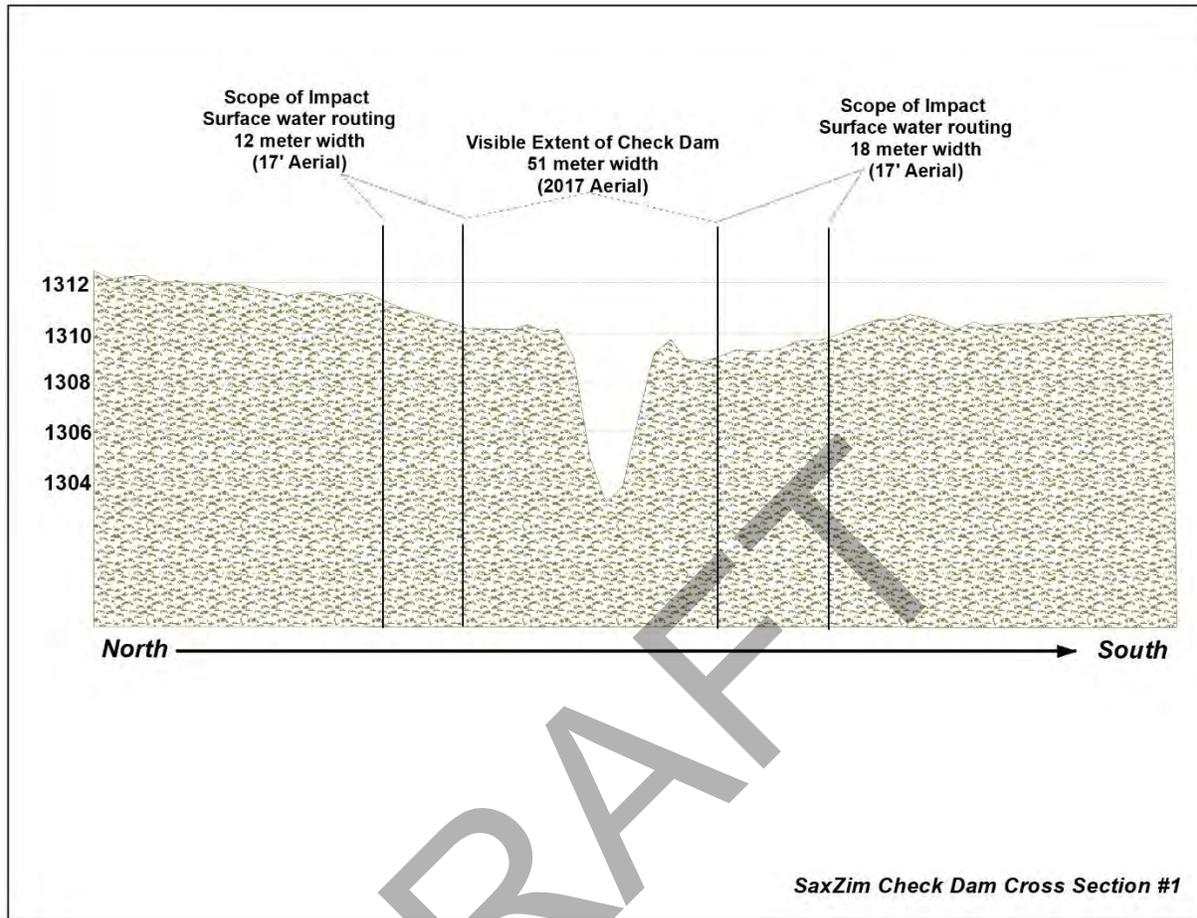
Graphic #11

Elevation data collected from LiDAR grids were converted into excel to generate a graph and eventually a profile of the peat surface across the transect. The LiDAR data identified the width of the particular ditch plug as approximately 51 meters (167 feet) and the impact from surface water routing as 12 meters (39 feet) and 17 meters (56 feet) wide respectively.

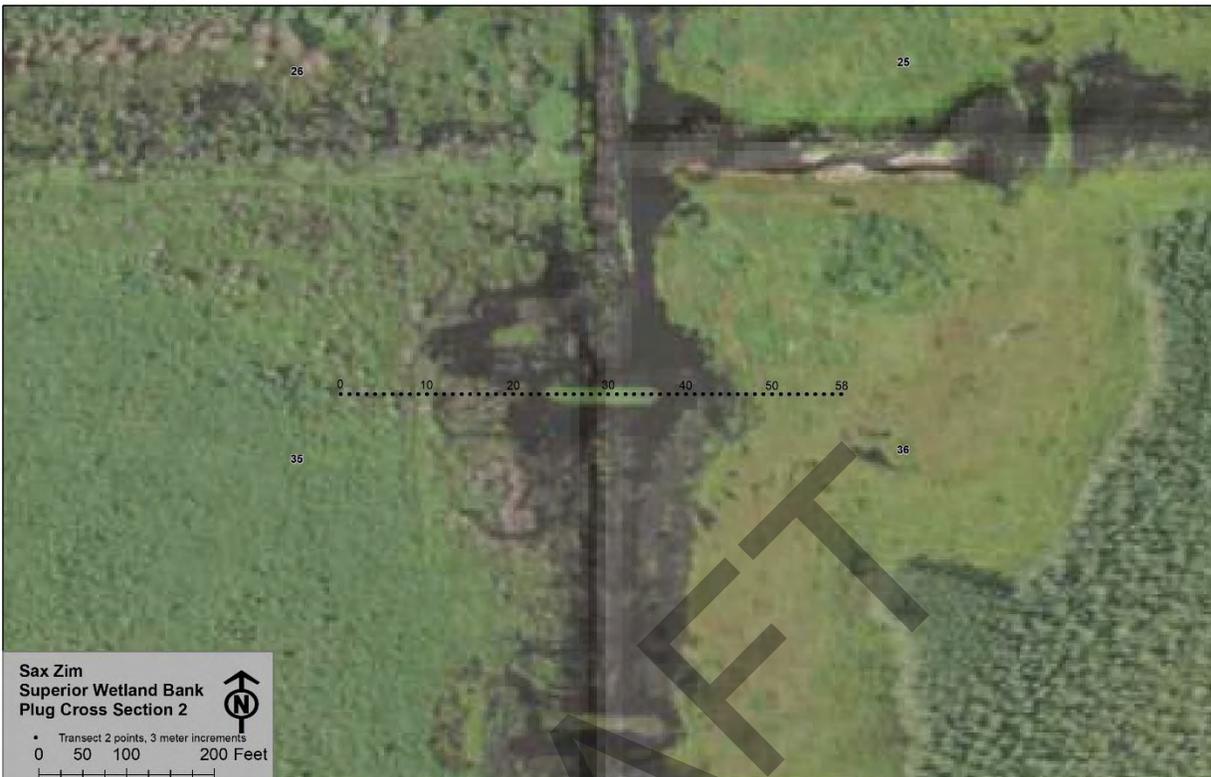
Graphic #12

Cross Section 2 is located 1 mile east of CSAH 7 and 1 mile north of Cross Section 1 (See Graphic #10). The image of the ditch check illustrates the ditch check has been substantially overwhelmed by ground or surface water flows. Cross section data was collected using the same methodology as Cross Section 1.

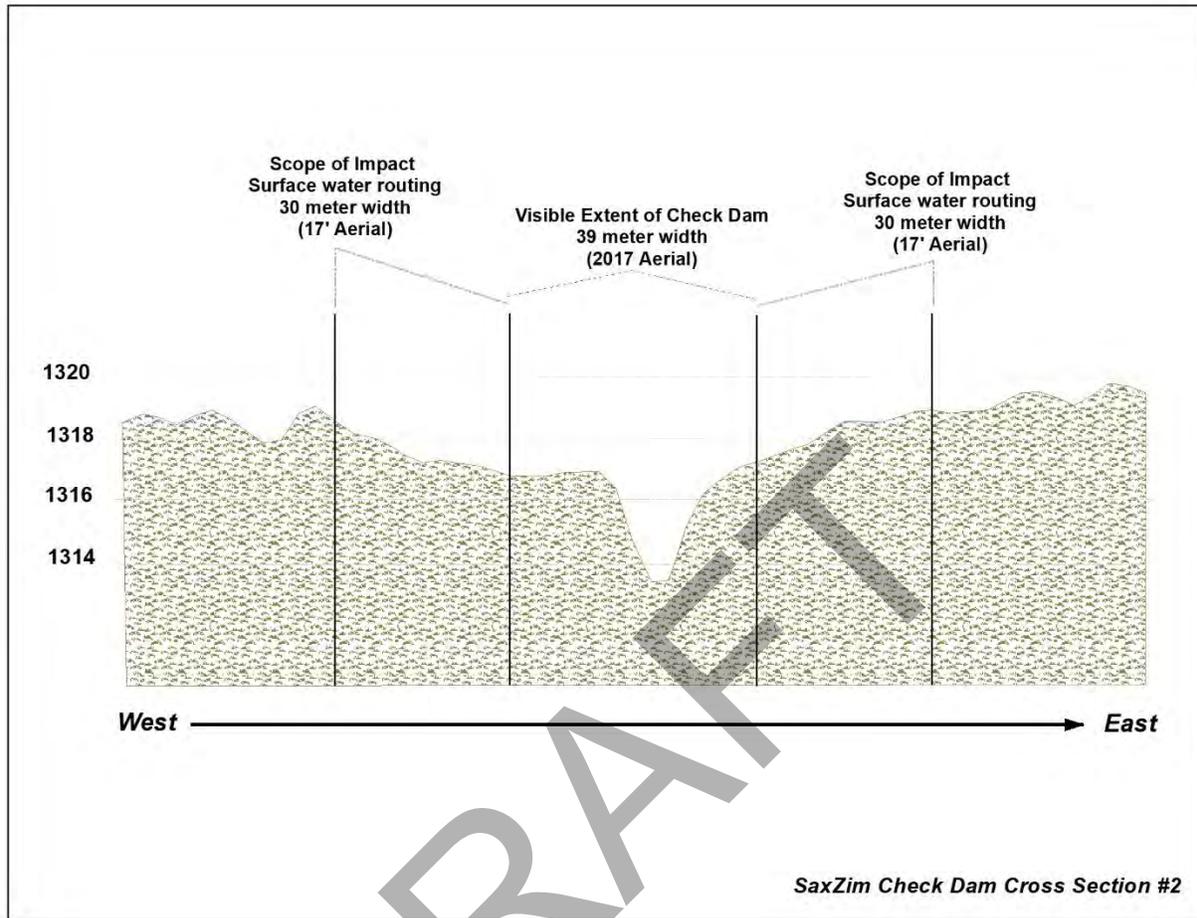
Graphic #13 illustrates the ditch profile at Cross Section 2. The profile illustrates that the check may have been adequately sized, or the width of inundation was outside the design scope of the check dam. The width of the check (based on aerial imagery) is 39 meters (127 feet) long and the surface water routing around check dam was 30 meters (98 feet) wide on either side of the check.

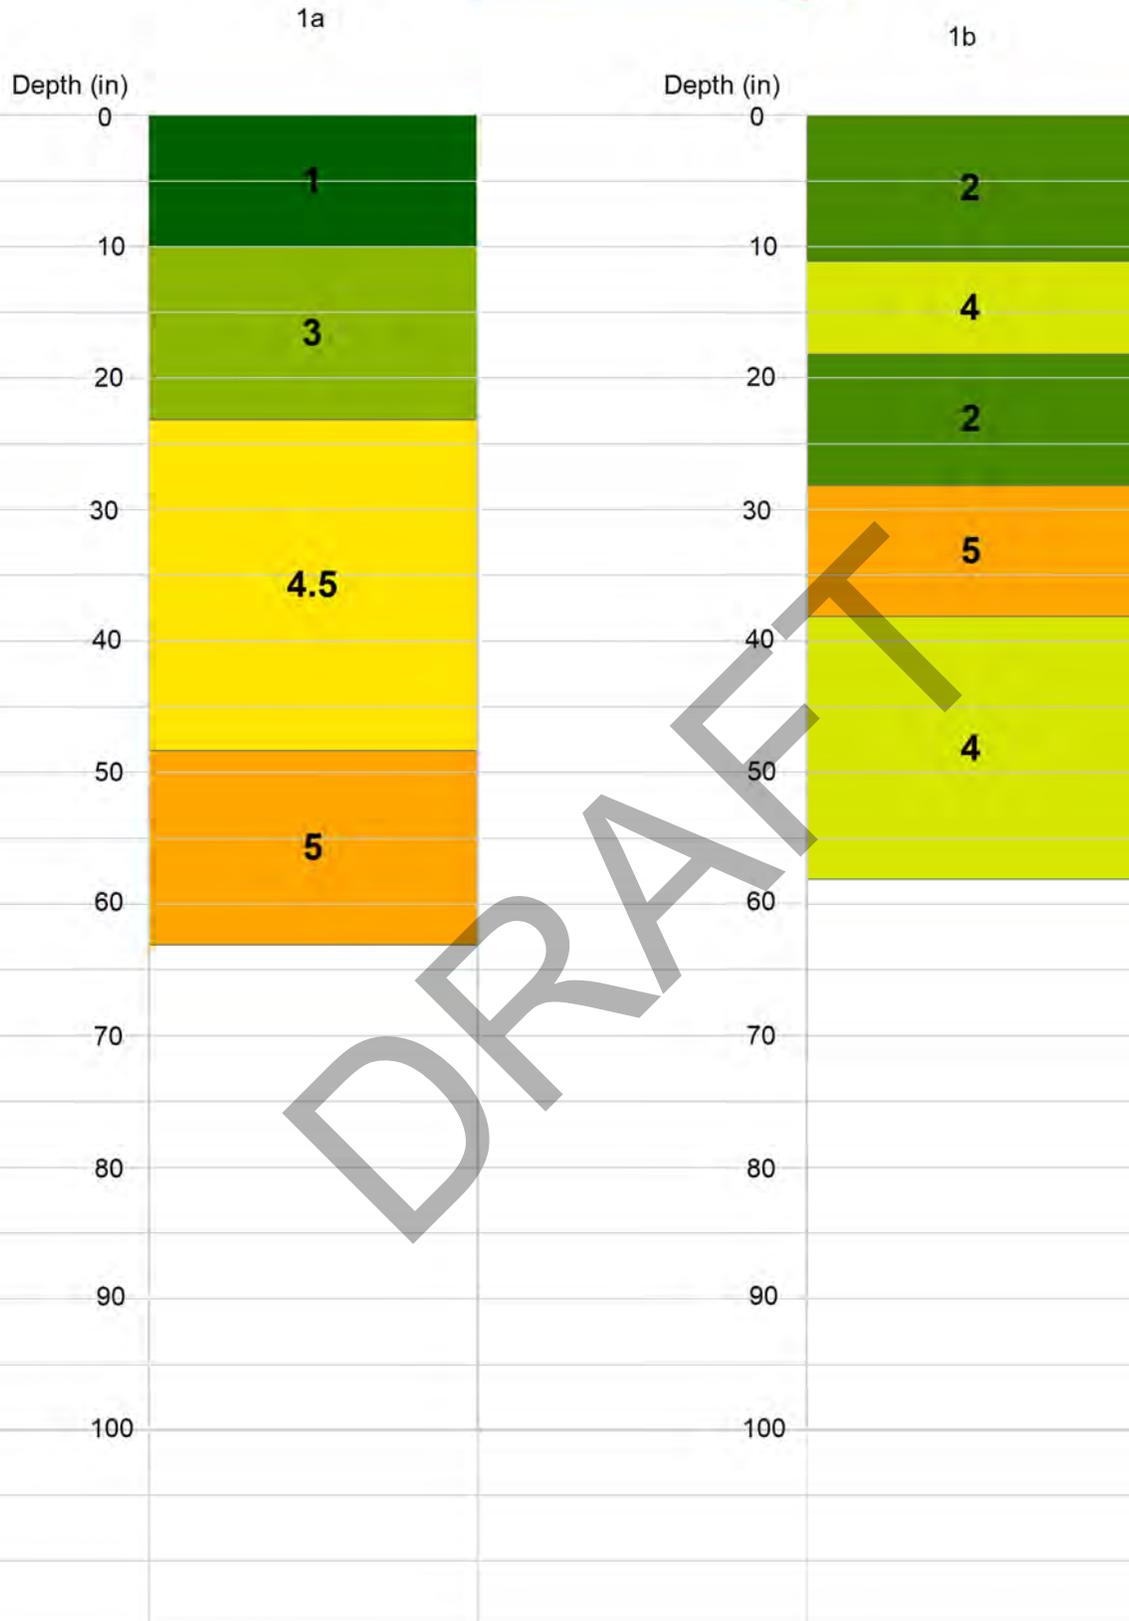
Transect #1 Sprague Creek Peatland
Peat Humification - Von Post Values

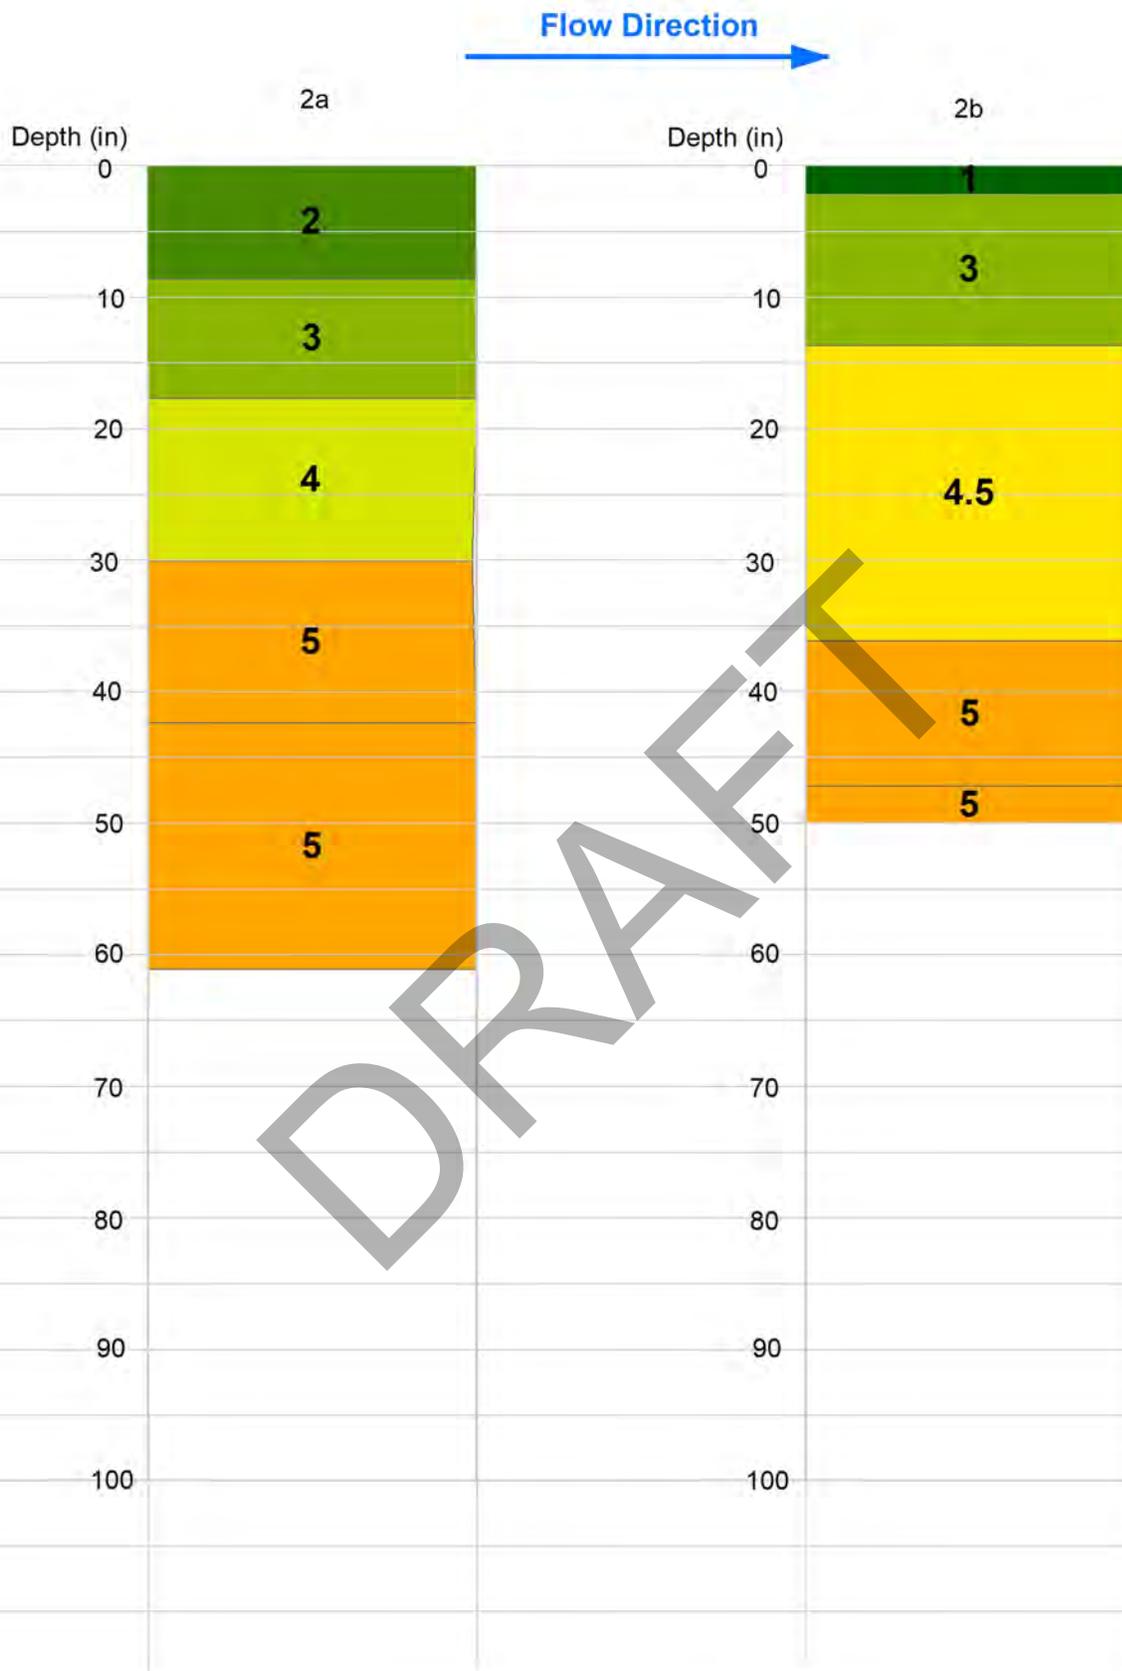
Transect #2 Sprague Creek Peatland
Peat Humification - Von Post Values

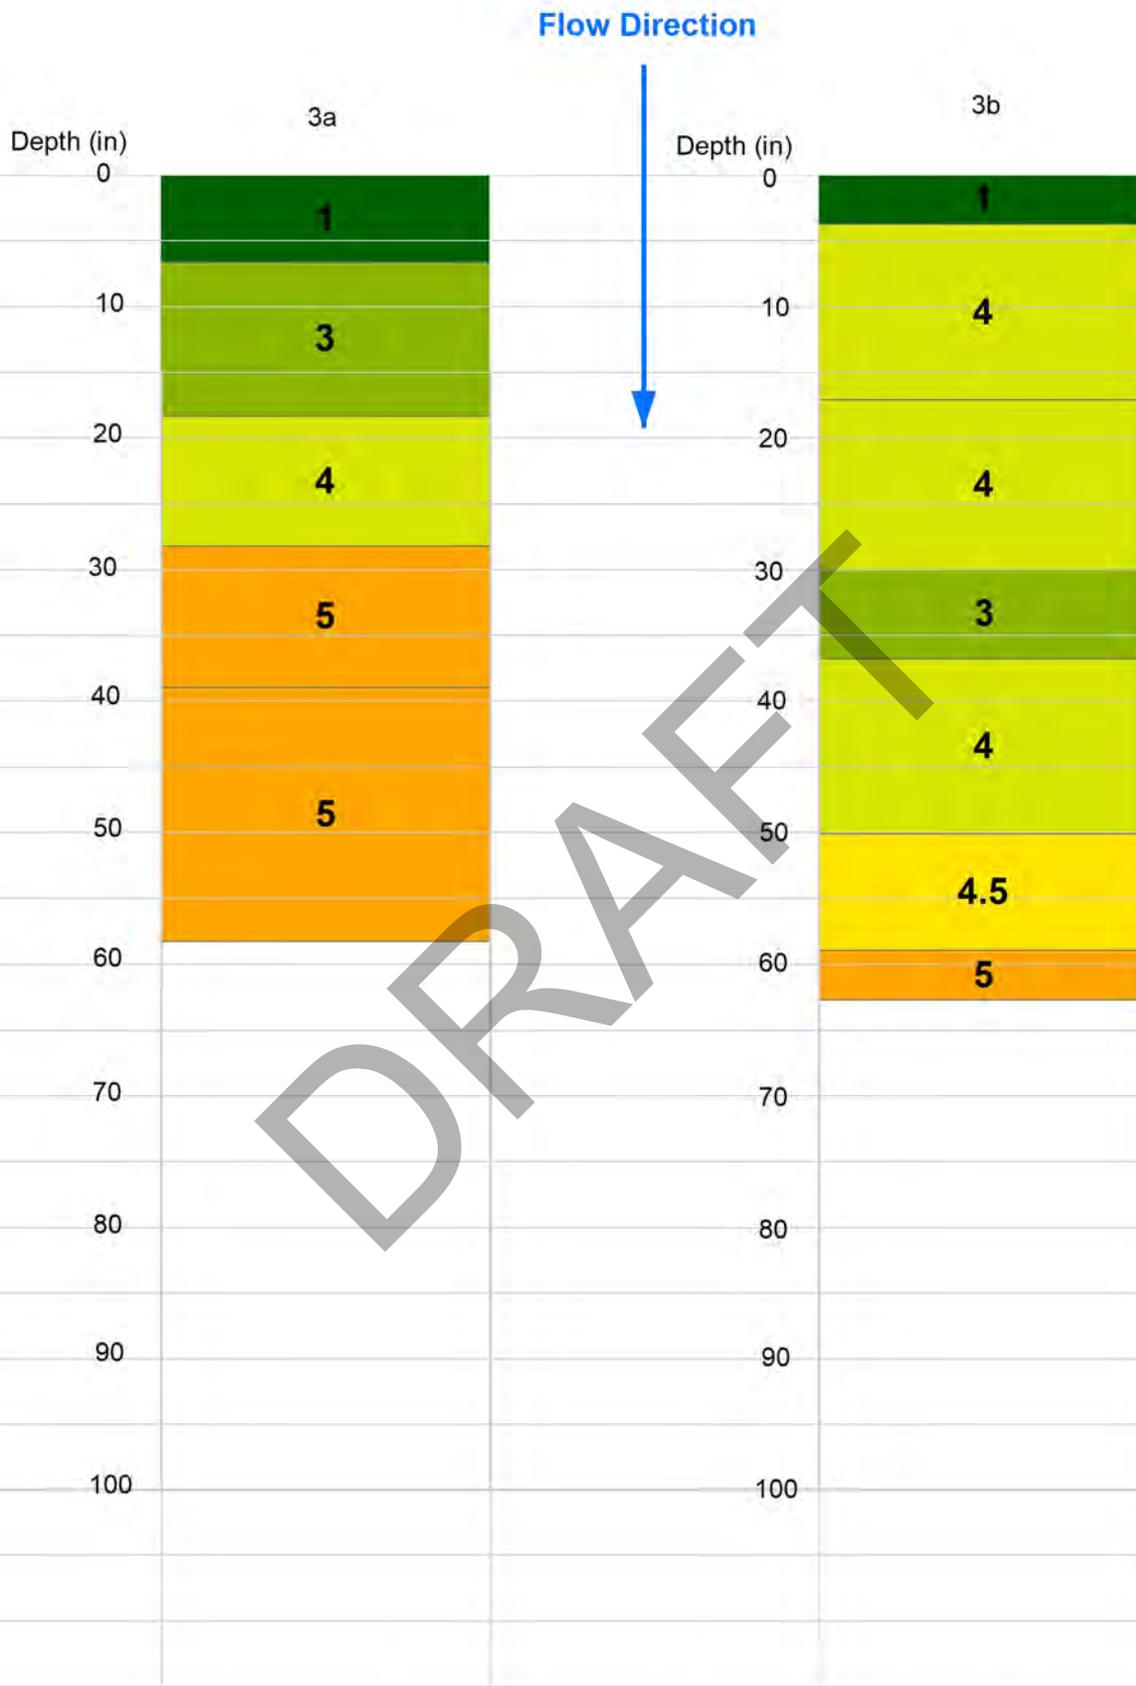
Transect #3 Sprague Creek Peatland
Peat Humification - Von Post Values

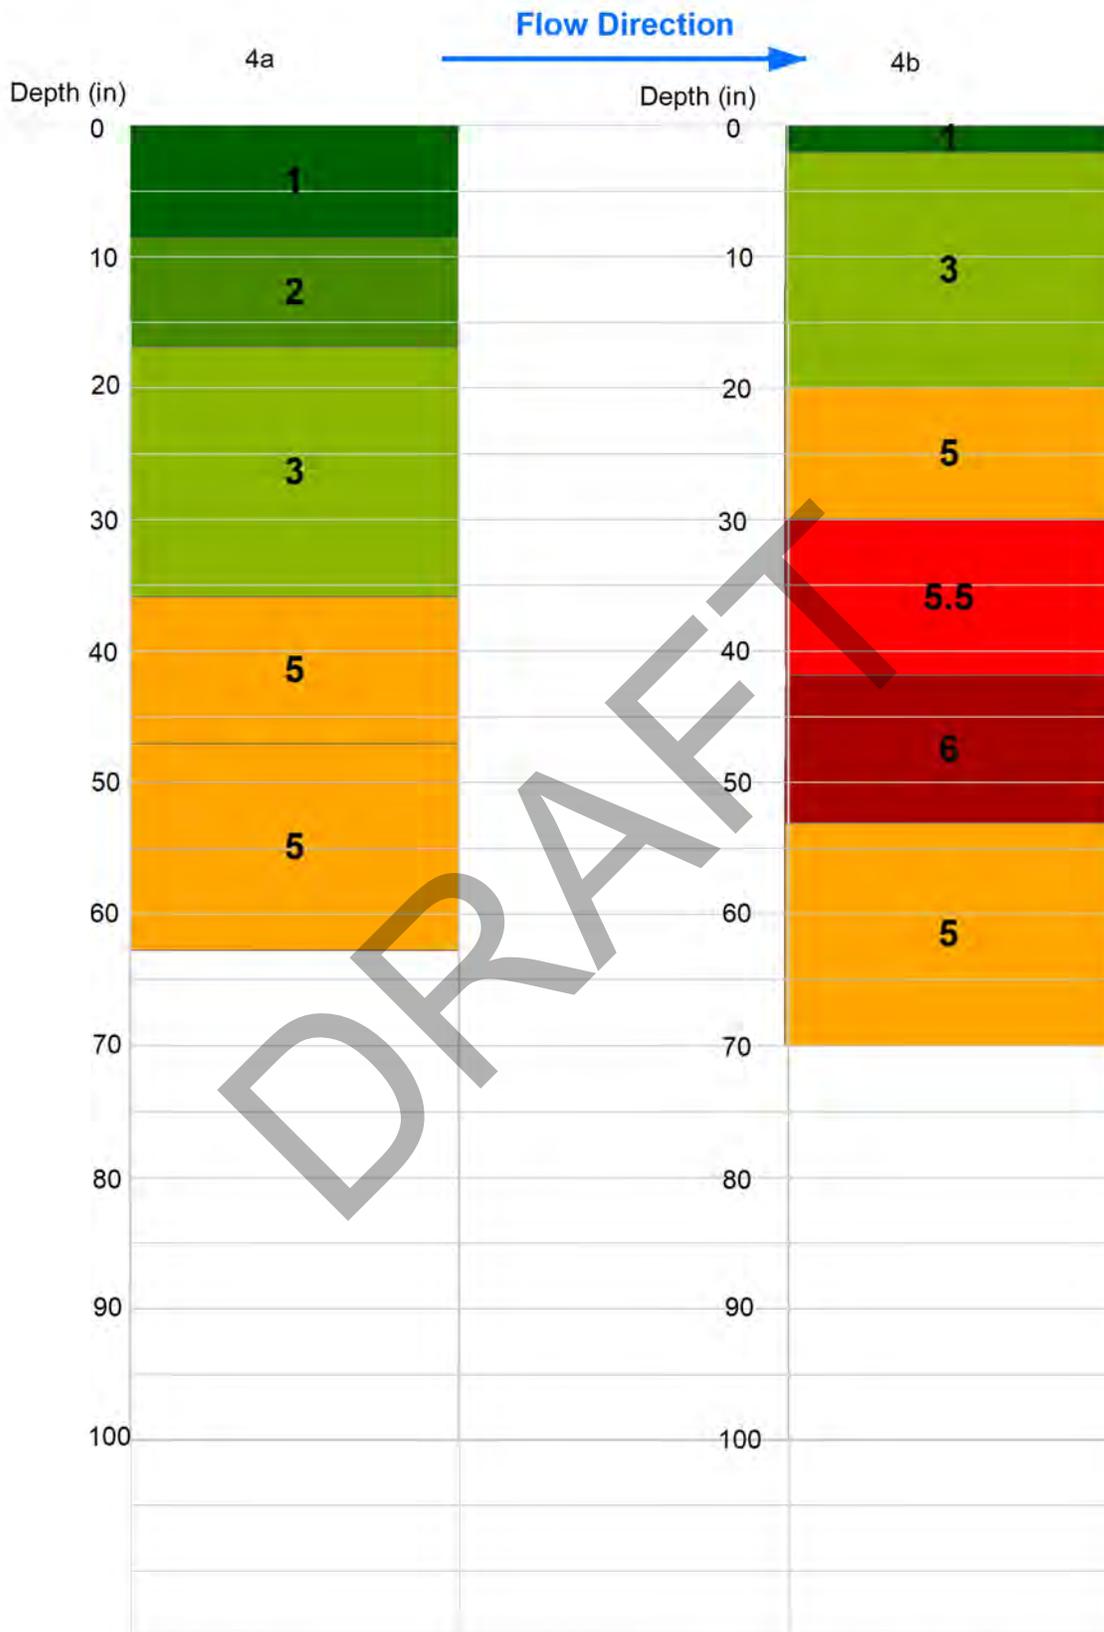
Transect #4 Sprague Creek Peatland
Peat Humification - Von Post Values

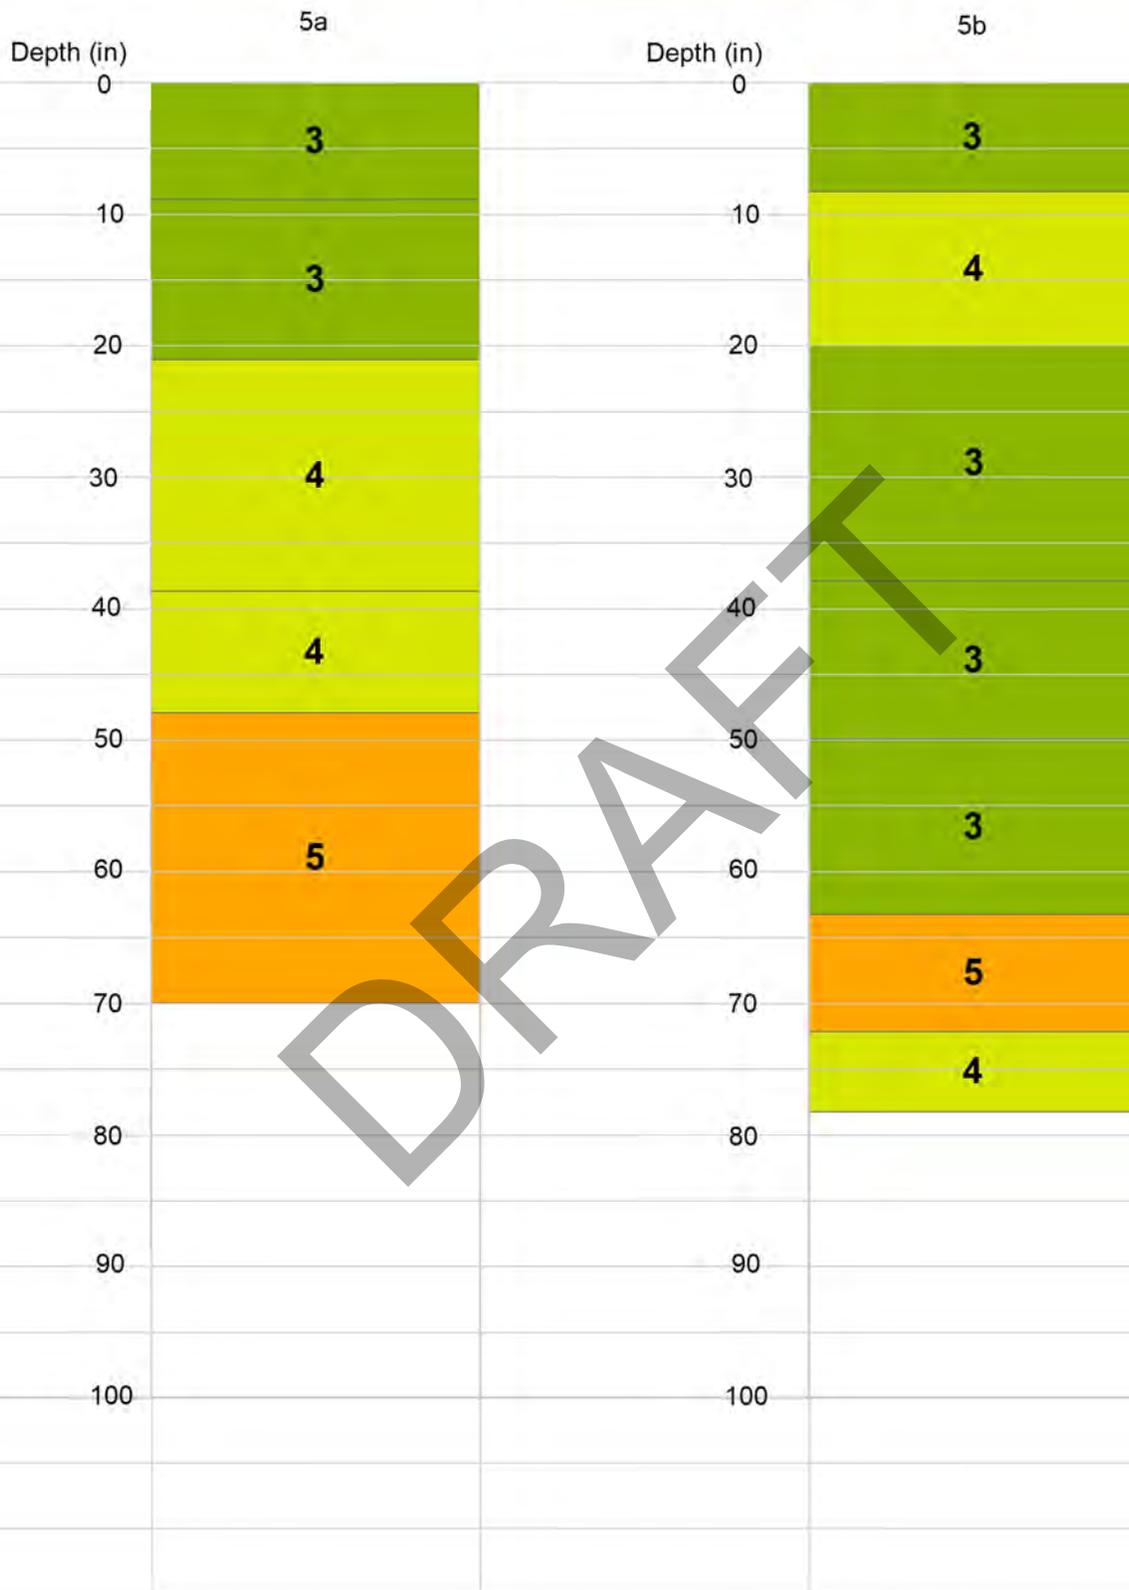
Flow Direction
