Sprague Creek Fen, Wetland Complex Restoration

Compensatory Mitigation Strategy for the Roseau Lake Restoration Project

Roseau River Watershed District

MNDNR Roseau River Wildlife Management Area Office

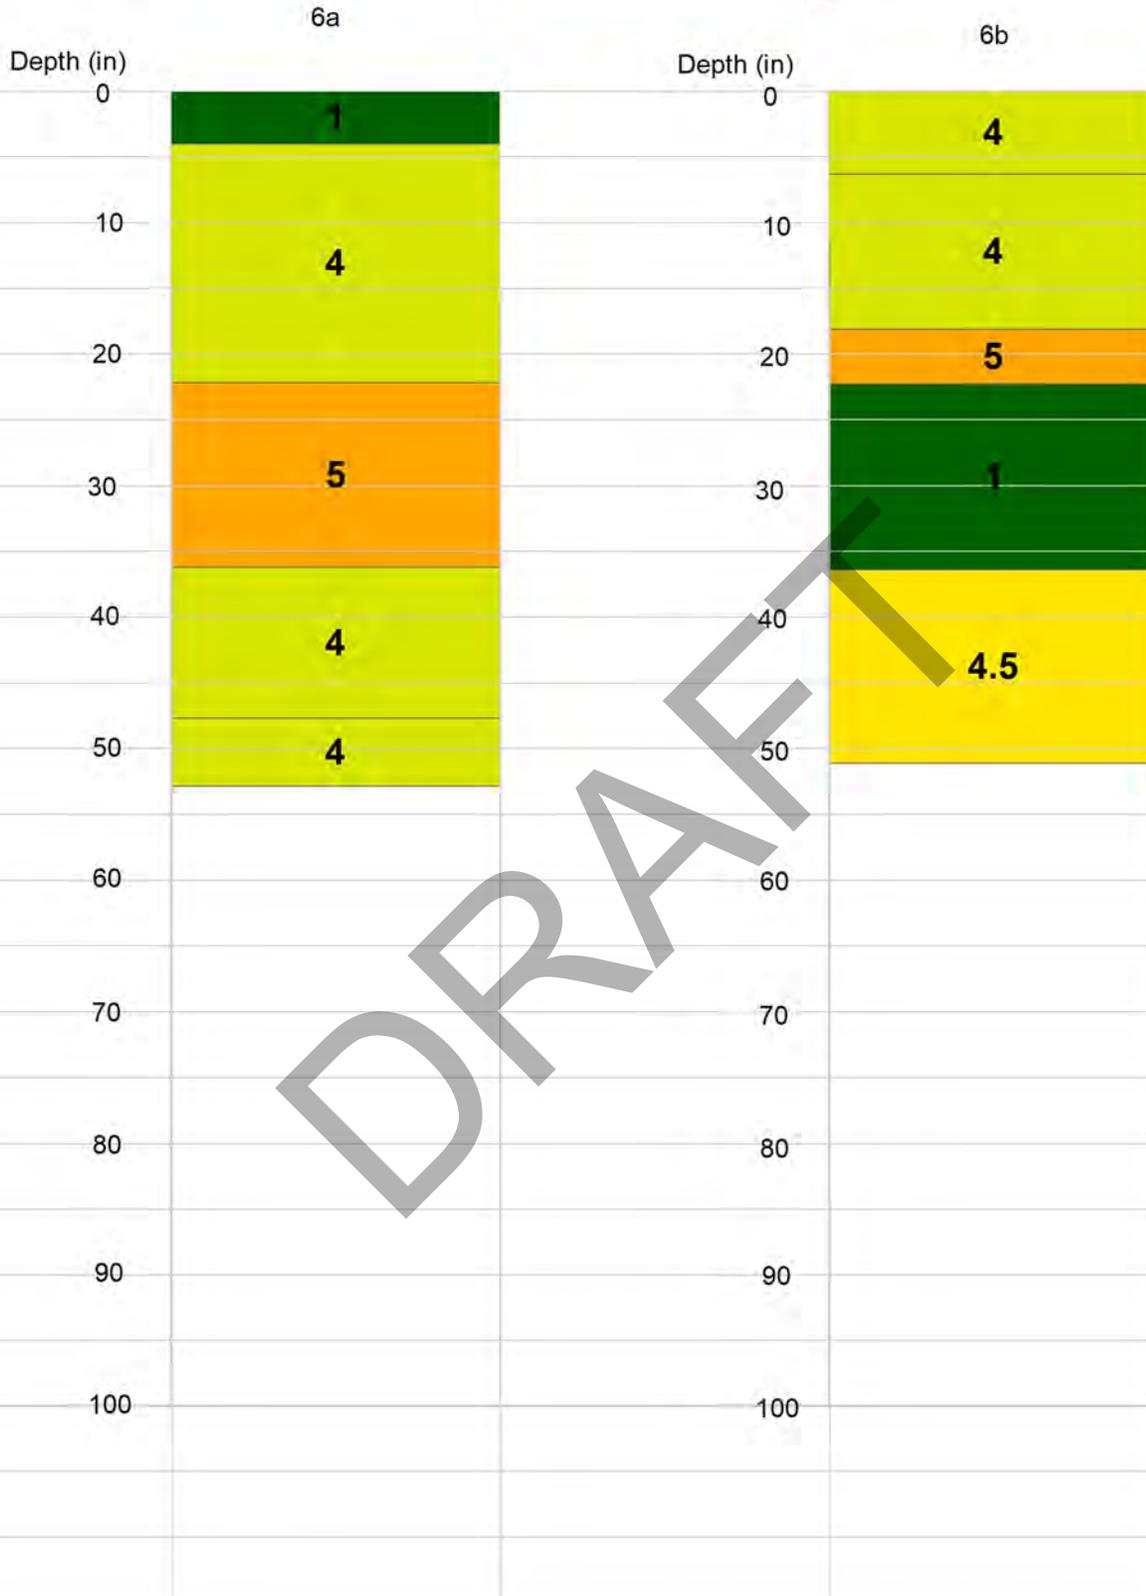
Transect #5 Sprague Creek Peatland
Peat Humification - Von Post Values

Flow Direction
