ROSEAU RIVER WATERSHED DISTRICT

Fixes bring 100-year-old ditch into alignment with modern ag practices

Clean Water Fund projects curb rain-induced, perennial erosion

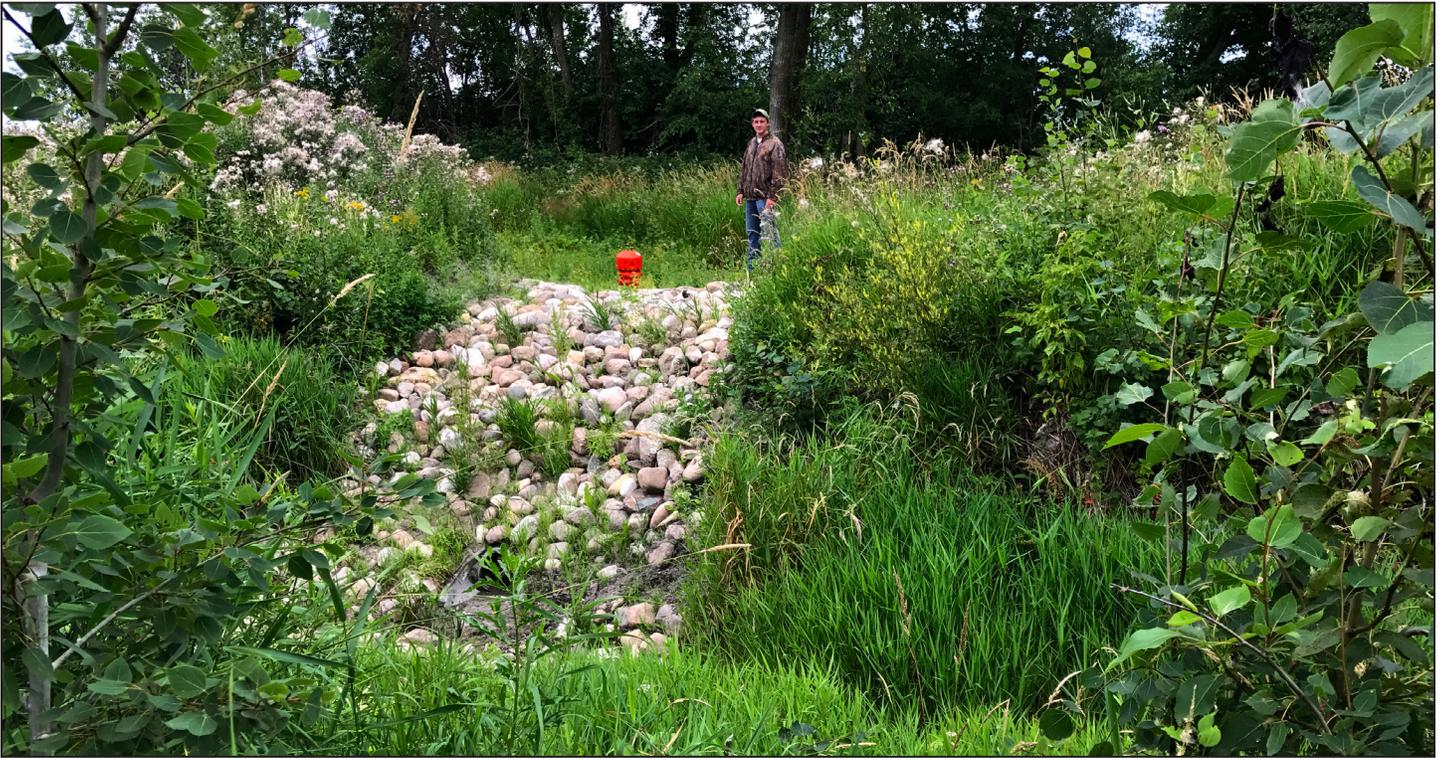
Torin McCormack, Roseau River Watershed District specialist, puts into perspective the size of a grade stabilization structure bordering Tony Brateng's fields on Aug. 2 south of Roseau. Contractors removed trees, resloped the ditch banks and lined them with fabric and rock where erosion once cut away at the field and sediment once entered the creek that empties into the Roseau River. **Photo Credits:** Ann Wessel, BWSR

Contractors removed some trees, resloped the ditch banks, and lined the banks with fabric and rock. Rocks stabilized another spot where the creek was working its way into the field. Now, a sediment trap catches anything that’s carried through the grass.

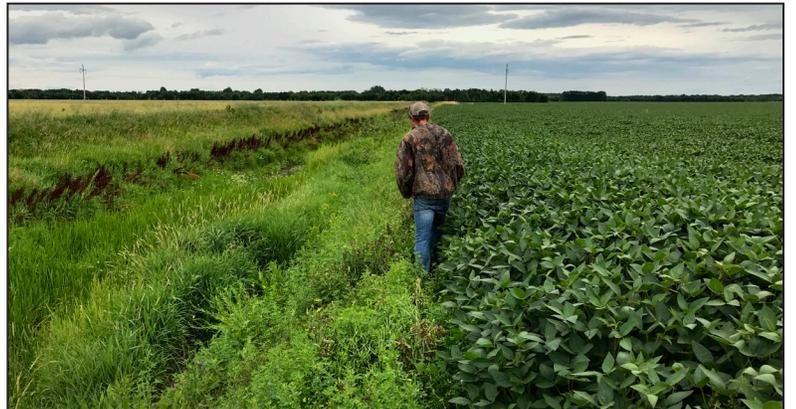
McCormack walks along Roseau County Ditch 8, which empties into the Roseau River. A \$147,700 Clean Water Fund project will keep an estimated 275 tons of sediment out of the turbidity-impaired river.

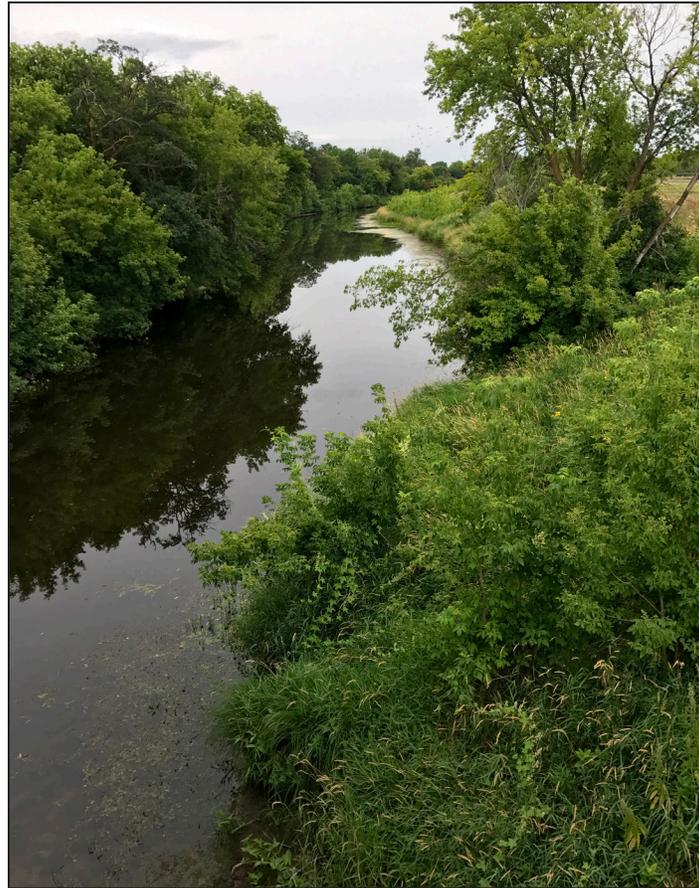
The Roseau River runs through Roseau. Nine miles across the U.S.-Canada border it joins the Red River, which empties into Lake Winnipeg. Fixes to a 100-year-old ditch system will cut soil erosion and the river’s turbidity.

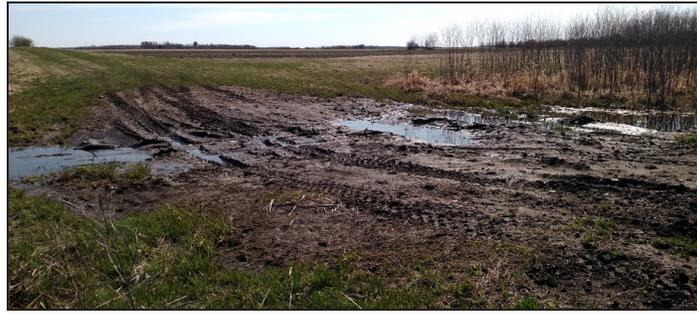
In wet conditions, this minimum-maintenance road was nearly impassable. The road had been cut in low, swampy spots. It drew big trucks with mud tires. Photo Credit: Roseau River Watershed District

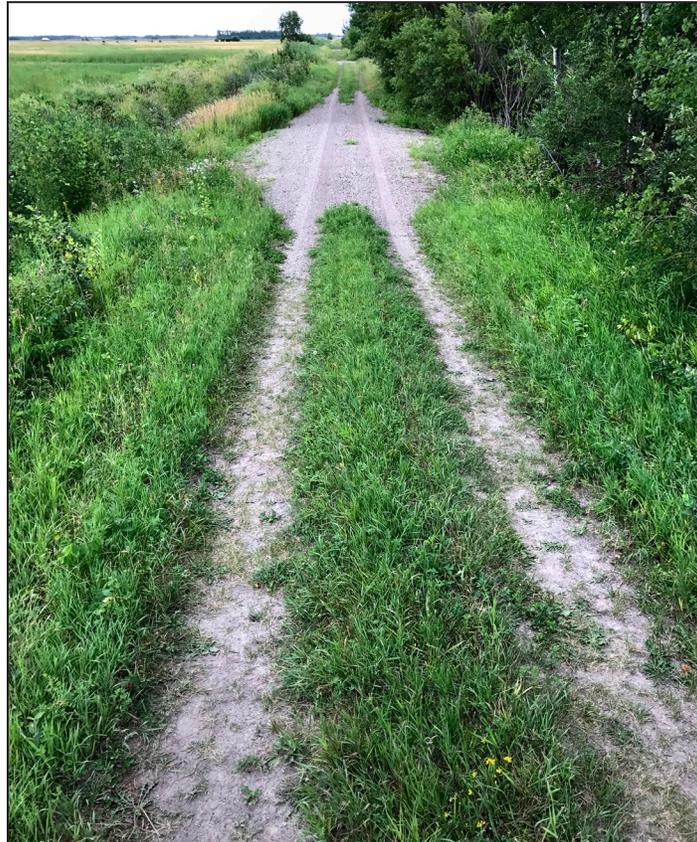
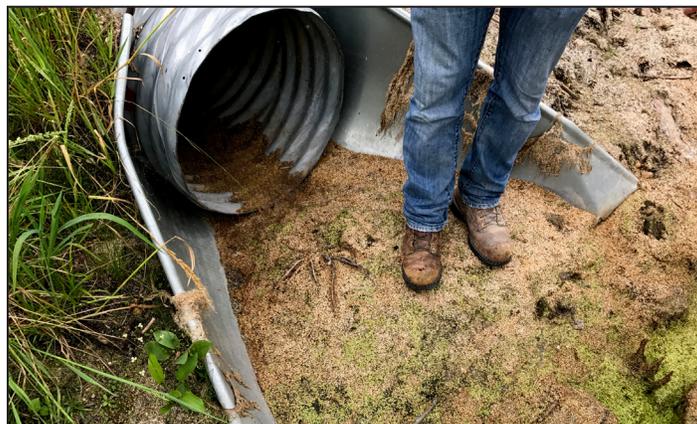
Top: Nine side-inlet control structures were installed in fall 2016 where a lateral feeding County Ditch 8 runs parallel to a mile-long stretch of minimum maintenance road. Crushed asphalt tops the road where culverts were installed. The road slices through long, linear wetlands. **Bottom:** Once fixes are made farther up in the watershed, the culverts will be cleared of excess sediment. **Photo Credits:** Ann Wessel, BWSR

Now, crushed asphalt tops the road where nine side-inlet control structures were installed last fall. Because the primary land use was wetland or forest – not farming – ditch funds paid the required match.

The structures allow sediment to settle back onto the land, reducing the load downstream. The ditch will become more efficient once sources of inland sedimentation are identified and fixed, and the overgrown willows and cattails can be cleared.

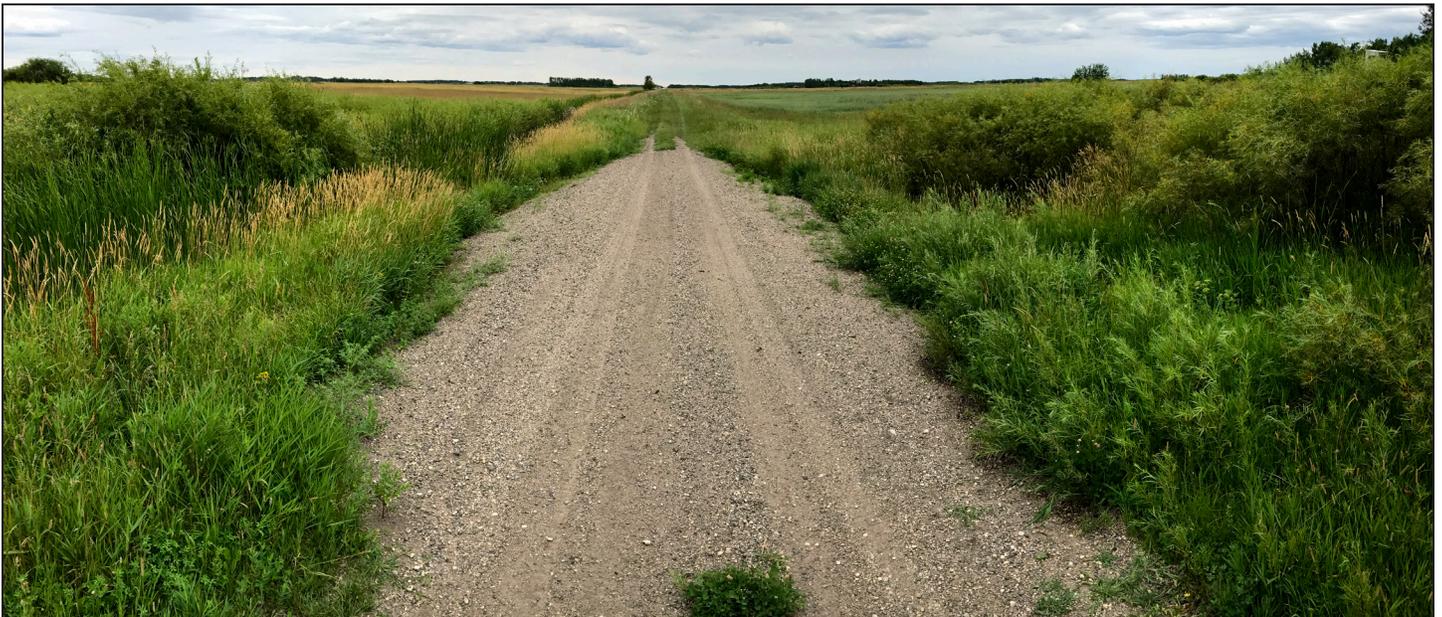
Top: Before the nine side-inlet control structures were installed, the lateral feeding County Ditch 8 drew thrill-seekers with big pickups with mud tires. Each culvert was sized to fit the area affected. **Bottom:** A perforated, above-ground inlet pipe provides another release for backed-up water at locations where water is meant to stand for a short time, allowing sediment to settle out. **Photo Credits:** Ann Wessel, BWSR

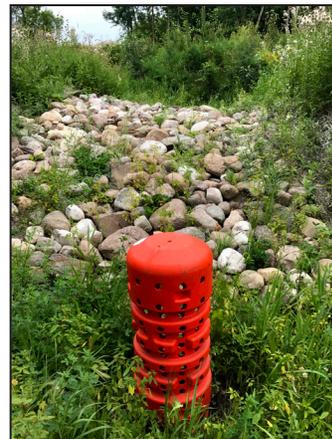
“It’s 6 acres plus, but it’s probably less than that now because all the banks have been washing in,” Mekash said. “It used to be you could put a board across

there. As kids, you could just walk across there. Now it’s way bigger than that.”

Mekash said where once the land was flat, it had sloped to the water.

“They’re straight vertical walls, and they continue to fail over time into the channel and then wash away downstream,” McCormack said. “We’re just trying to help the landowner by retaining their yard and help the river by keeping the material on the landscape and out of the channel.”
